Update on activity at the Lakeside and Haverthwaite Railway - October 2022

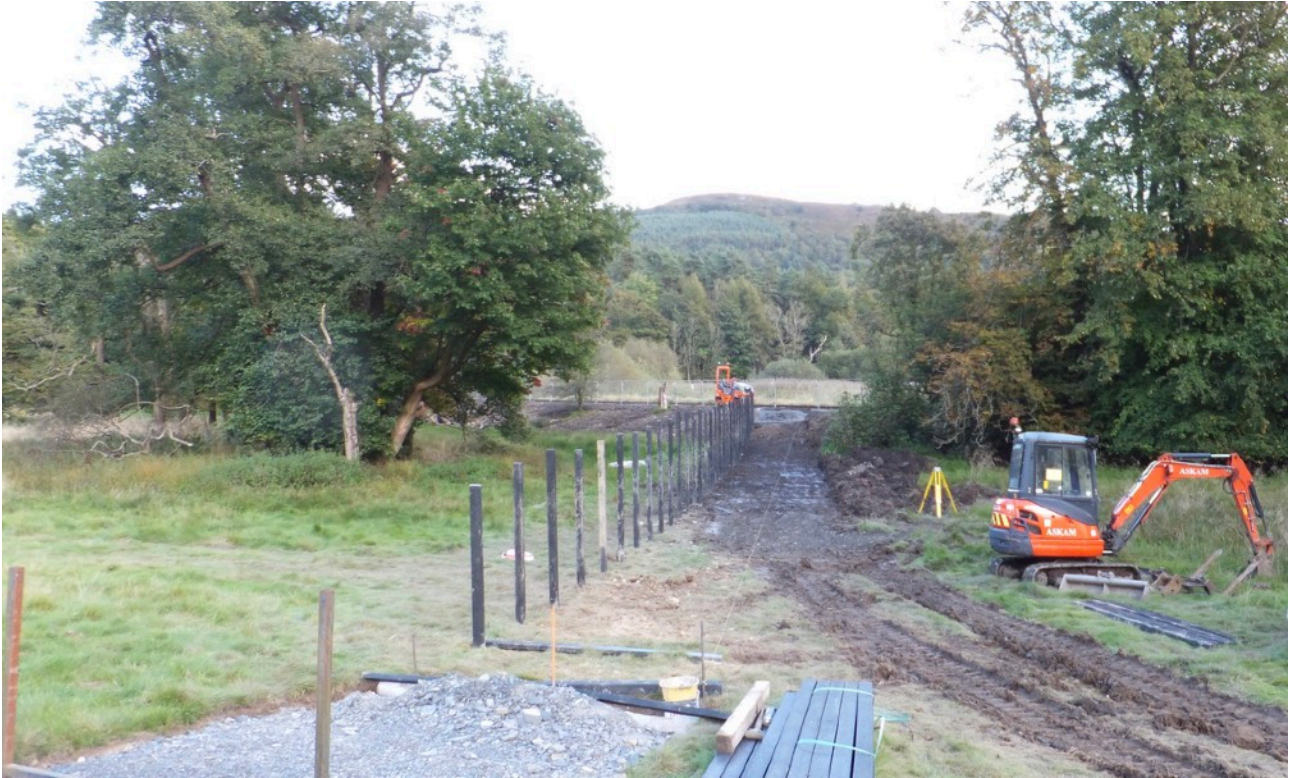
The new permissive path from Newby Bridge to Lakeside continues to make progress and the photo (below) shows the start of construction of a raised section where it leads into the adjacent field away from the railway track and over marshy ground. The railway can be seen in the centre of the picture (behind the orange path roller) and the lake shore is just beyond the trackbed.

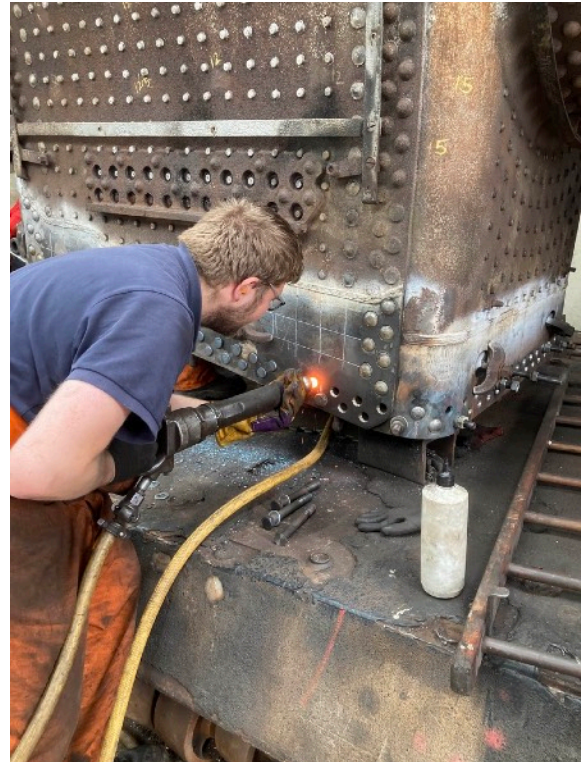
Riveting of the firebox foundation ring has been completed and all the rivets caulked. Photo (right) shows the riveting in progress in mid September. The photo also shows the marking out for new stays. Drilling of the plate for the side stays is now in progress.

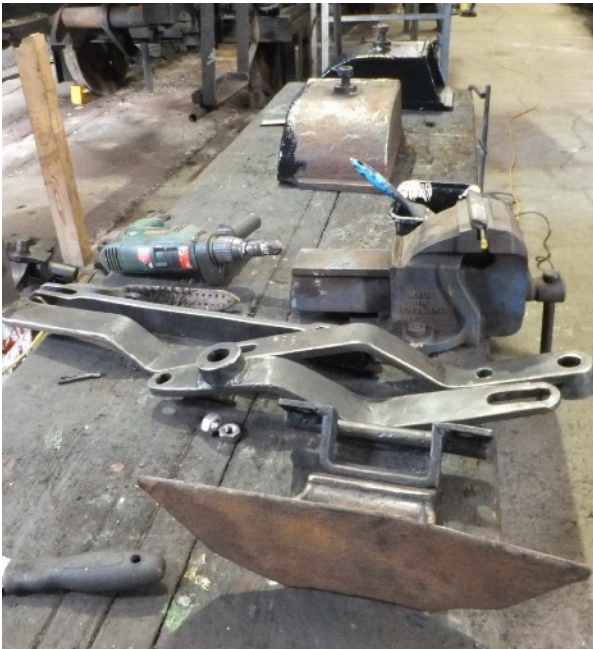
Strip and overhaul of the fire-hole door assembly has been started by the volunteers (photo left).

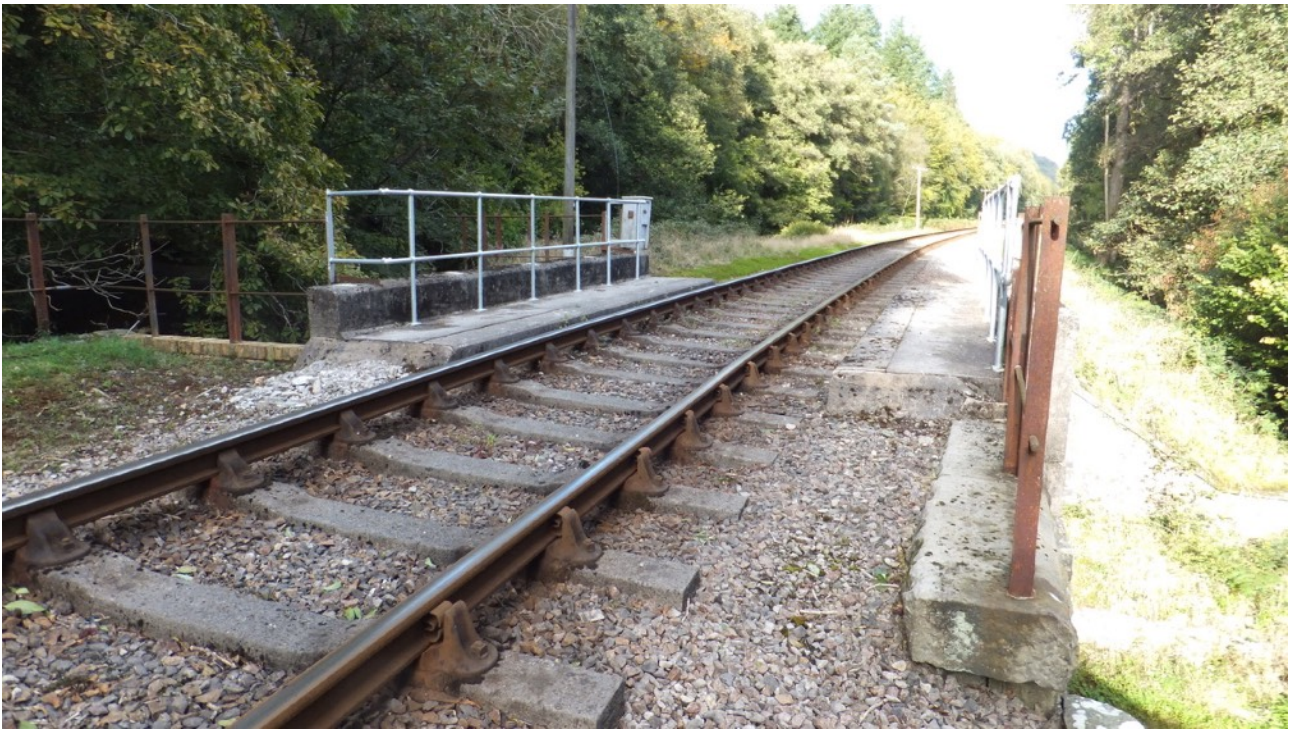
Improvements to safety barrier work have taken place over the last two months on Cuckoo Bridge near Linsty Green (photo above) and also on our bracket signals.

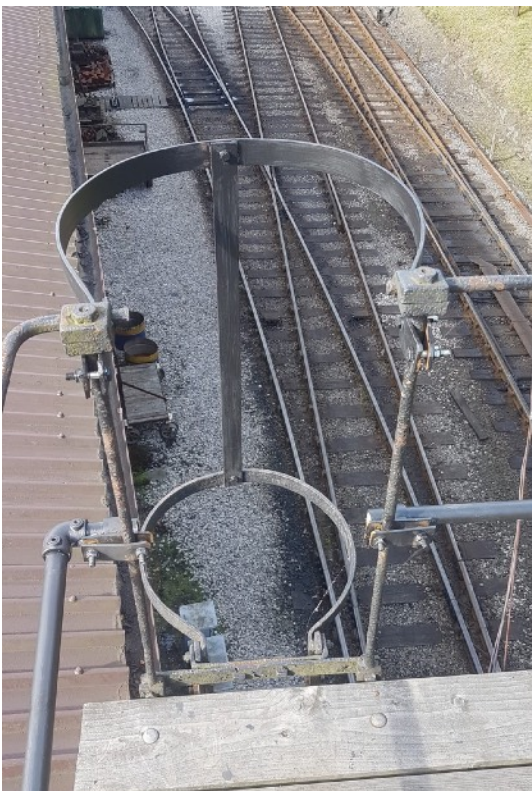
Photo (left) shows the extra hoop on Haverthwaite No.17 bracket signal ladder and (below) an additional platform rail. The John Fowler team are now progressing similar work on the two bracket signals at Lakeside,

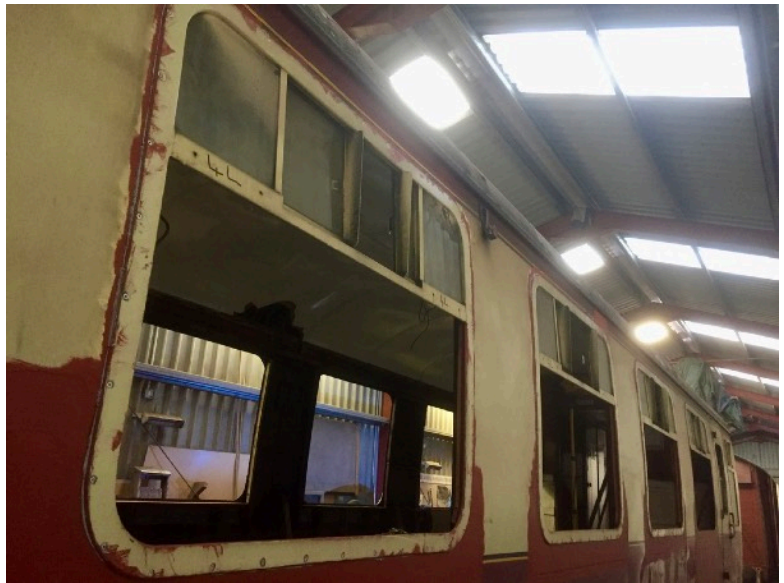
Bodywork repair continues on TSO M4410. Working one half of the coach at a time, the window internal frame supports have been replaced where necessary and lower skin sections replaced around the windows. On one (half) side as we can see in the photo (right) the window frames have been refitted. Work on the other side is following closely behind.

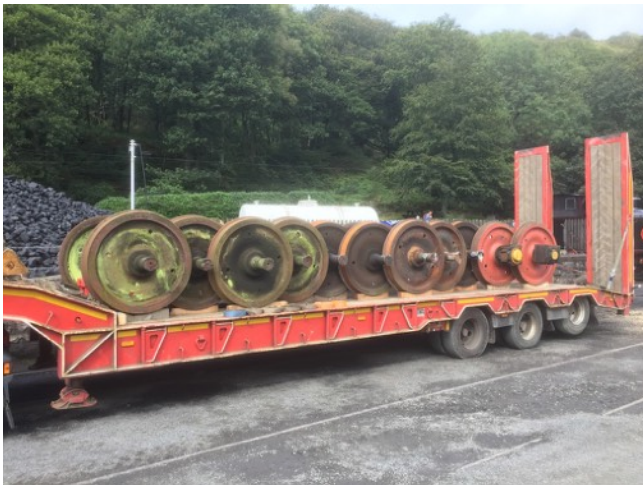
Several removed and spare Mk1 carriage wheel sets have been sent away for tyre turning. They can be seen here being loaded onto a trailer at Haverthwaite in mid September (Photo left).
