Update on activity at the Lakeside and Haverthwaite Railway - December 2022

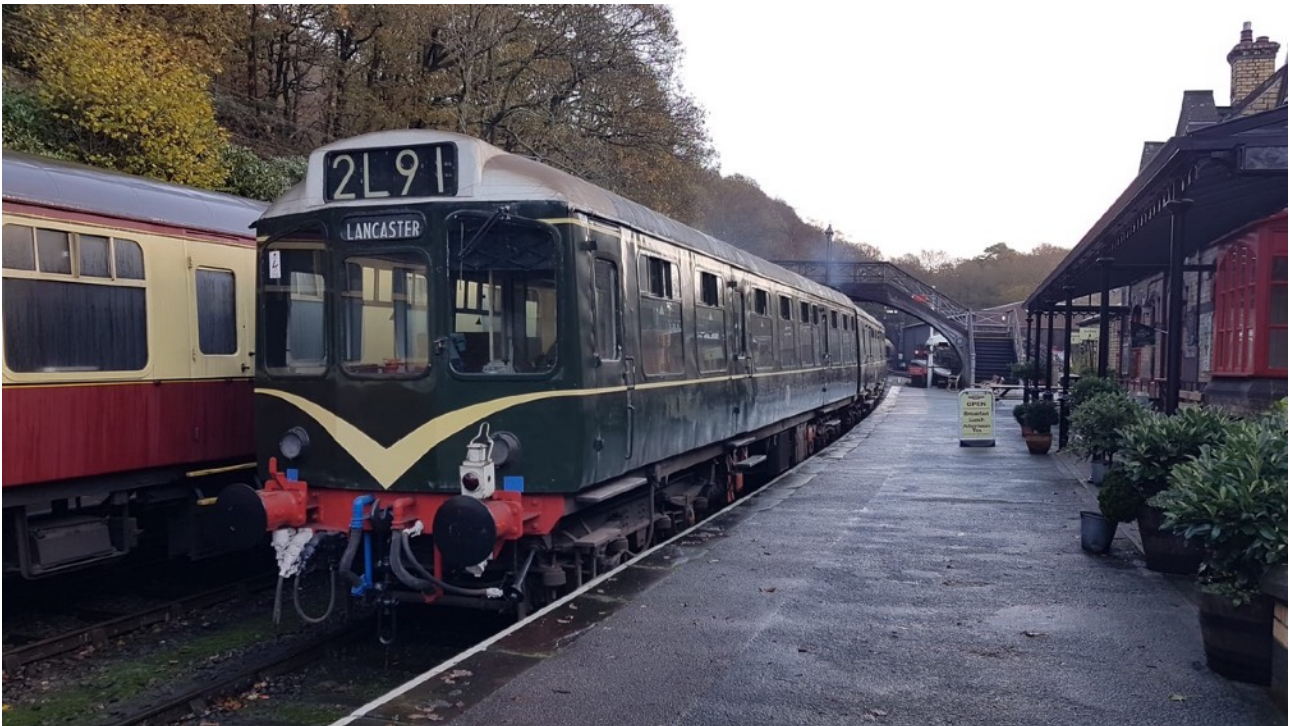
Our Calder Valley Class 110 DMU has not seen much use since 2019 so it was great to see it do a full day of running on a driver experience charter day in November (photo above).

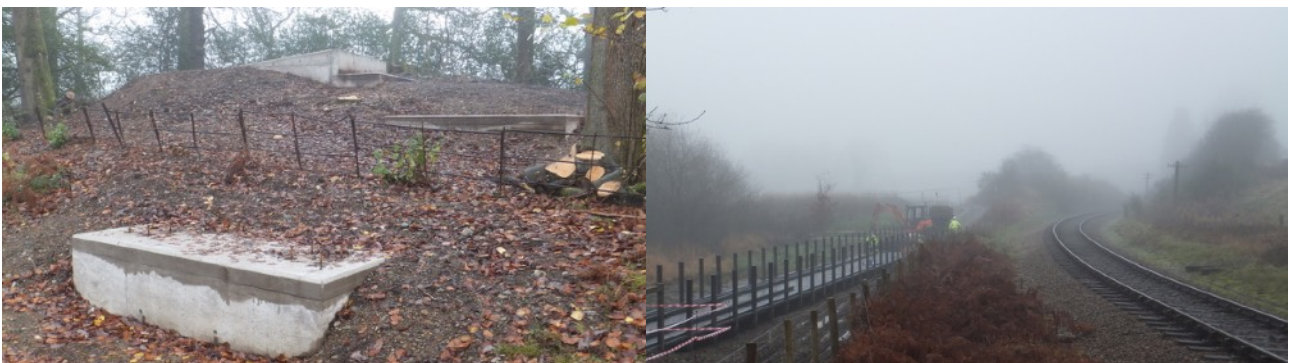
The new path between Newby Bridge and Lakeside has the bridge foundations in place ready for the arrival of span supports (photo below left) and the adjacent raised walkway approaching the Swan Hotel is progressing well (photo below right). The bridge structure sections are at Haverthwaite ready for transport to site by train.

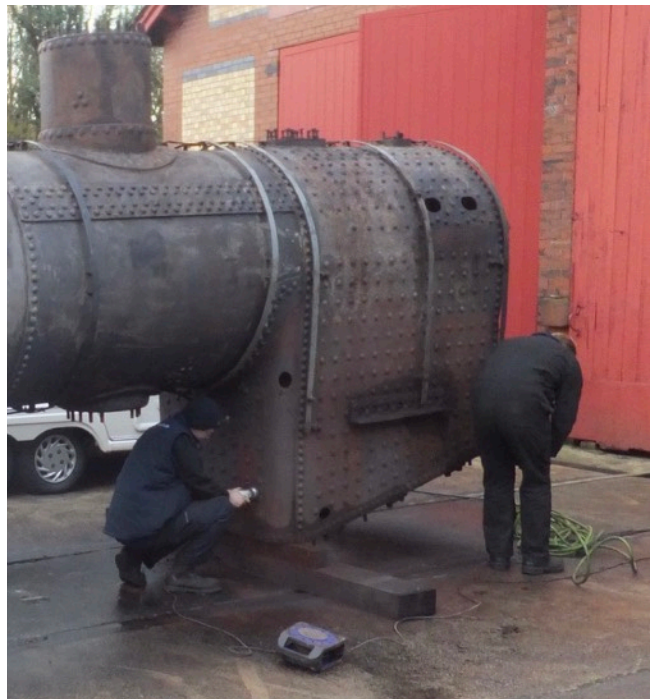
During November Victor was dismantled to release the boiler from the frames. The photo (right) shows the John Fowler & Co. staff subsequently preparing the outer firebox for Non Destructive Testing (NDT). The NDT examination took place on 16th November and the resultant inspection report did not highlight anything adverse. The boiler inspector is scheduled to visit in early December and it is hoped that our rapid overhaul plan will be agreed.

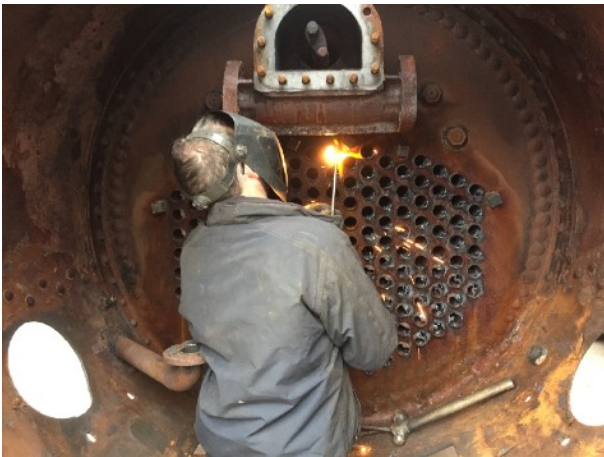
John Fowler engineers have started the process of removing the old boiler tubes as can be seen in the photo (above).

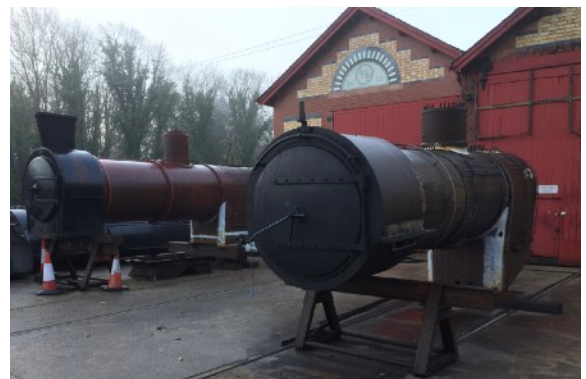
Repulse's boiler was prepared for NDT examination on the same date as Victor. The two boilers can be seen together (photo right) after the inspection. Repulse is on the left with its distinctive Giesl chimney.

Other than the boiler repairs that determined the need for boiler removal in the first place, the NDT report did not identify any further issues. A repair plan will be agreed with the boiler inspector shortly.

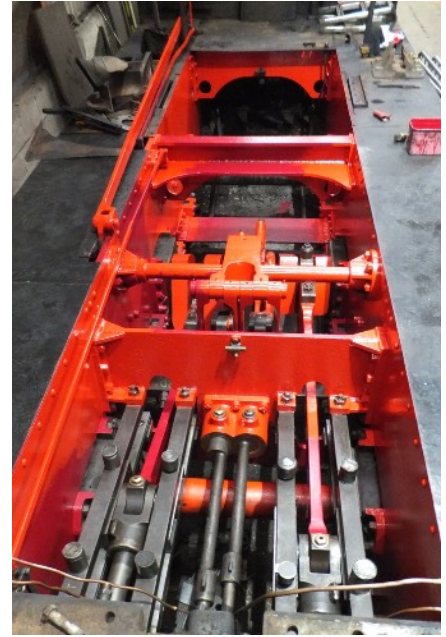
Just as with Victor, the boiler being out of the frames gives us the opportunity to get some cleaning done and a fresh coat of paint applied between the frames. The partially completed paintwork (photo right) is being done by staff member Mike Rothwell.

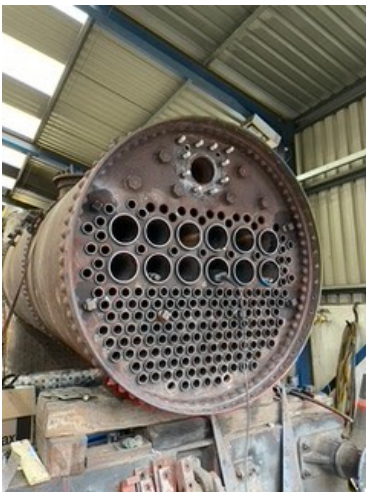
Fabrication of the superheater elements has commenced and is progressing well. The fitting of smoke and flue tubes is well advanced with nearly all the tubes in place with the beading and expanding still to complete. See photo (left).

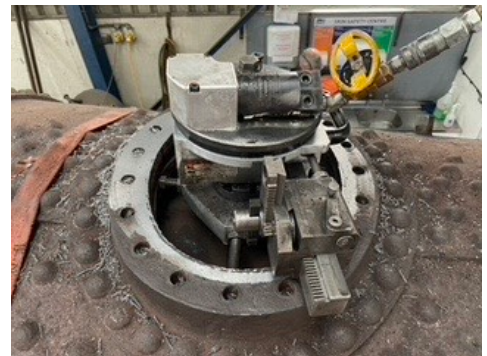
The top feed flange face can be seen during machining (photo above right). All boiler mount faces have now been machined and all mounting studs fitted.

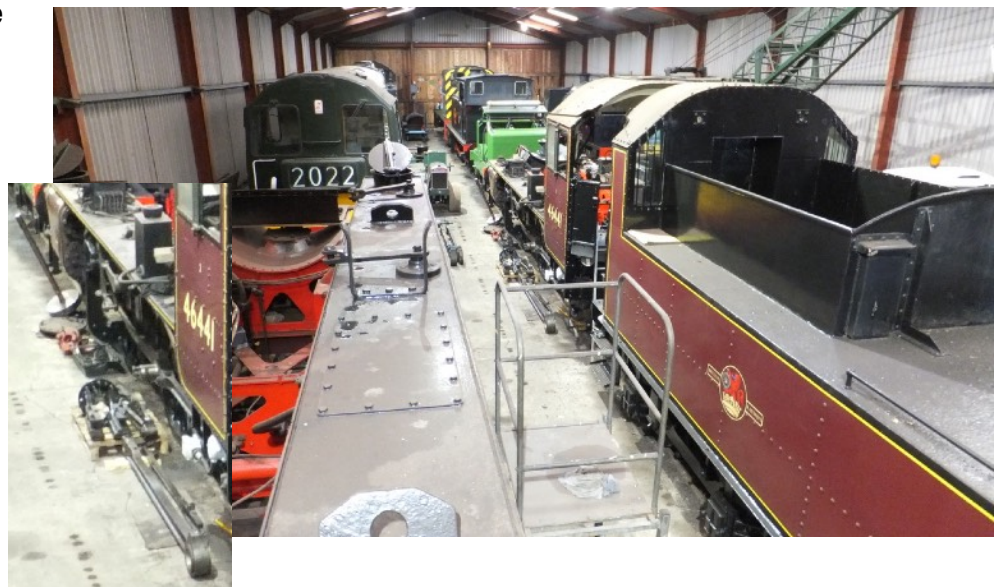
The piston and valve assemblies, piston and valve covers, valve gear kit, crossheads and connecting rods have all been laid out alongside the locomotive in preparation for re-assembly as can be seen in the middle of the photo (right and inset).

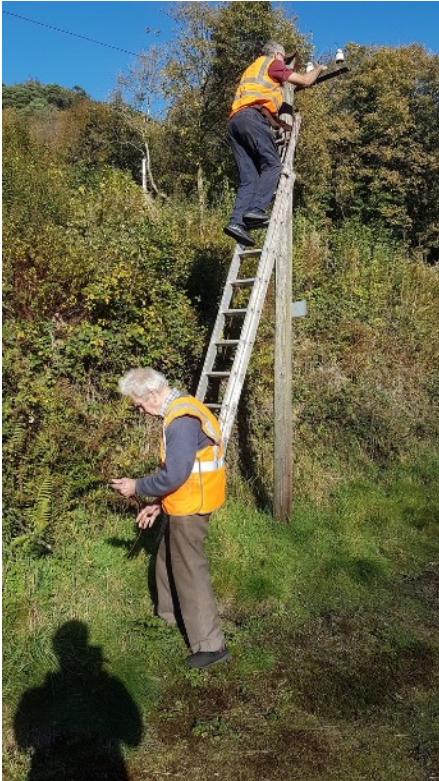
Volunteer Keith Brewer supported by Fred Jones are carrying out a programme of work to repair the telegraph route between Haverthwaite and Lakeside. This involves replacement of many pole cross arms and sections of wire. They can be seen at work (photo left) near Newby Bridge. The new path near Lakeside has also led to the need to move the routing of the telegraph cabling.

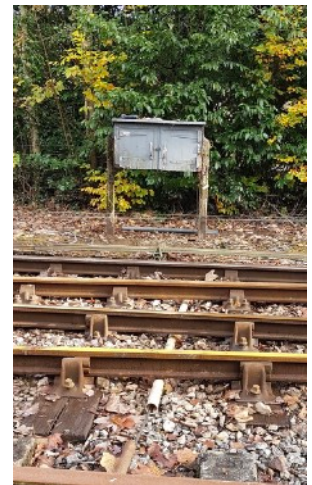
At the Lakeside station end volunteer Cliff Kilshaw has moved the telegraph cupboard away from the new path (photo right) and created two new cable links boxes. Each of these are concreted into the ground. Once in place, the rerouted telegraph cables coming from Haverthwaite will connect with the Lakeside end infrastructure at the cupboard.

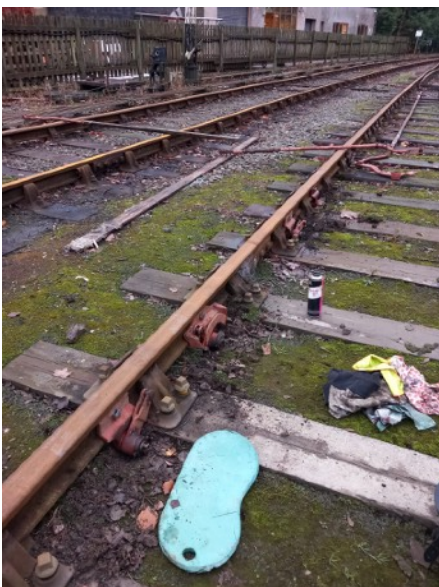
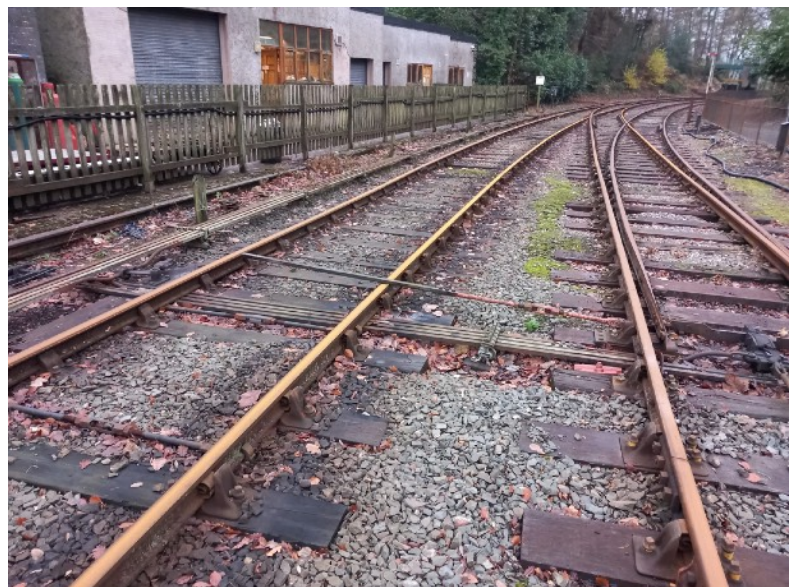
Also at Lakeside, Cliff is preparing to reconnect the 16A points leading to what was the long carriage siding in BR days. This can be seen on the top right of the photo (below right). These points have been previously clipped in a fixed position for the run round loop with the siding isolated. To reinstate signal box operation, the refurbished rocker arms (photo below left) have been fitted and rodding laid out in preparation for connection of point blade actuation and interlocking.
