## **Update on activity at the Lakeside and Haverthwaite Railway - April 2023**

### **General Status**

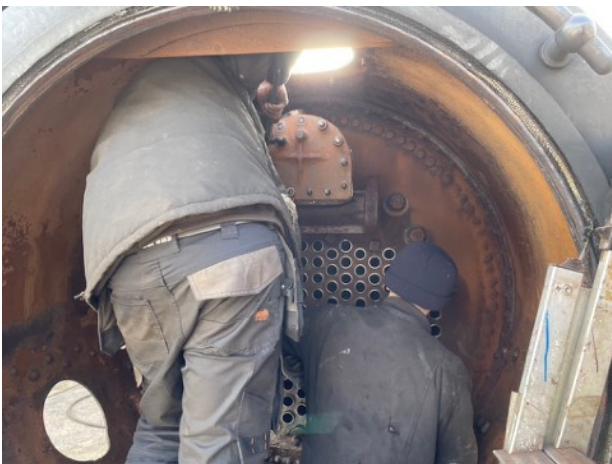
Victor's boiler was blanked up in readiness for hydraulic testing. Photos below show the John Fowler & Co. team at work. Photo (below left) shows Jack Dibnah fitting the regulator valve cover following valve overhaul. Also in the smokebox is Jack Walker who is rectifying any minor tube leaks as the boiler is filled and initial hydraulic pressure is applied. Photo (below right) shows Peter Akrigg at the firebox end, ensuring that the tube ends are watertight.

The boiler has subsequently been successfully hydraulic tested (in the presence of the boiler inspector). The steam test is anticipated before the end of April

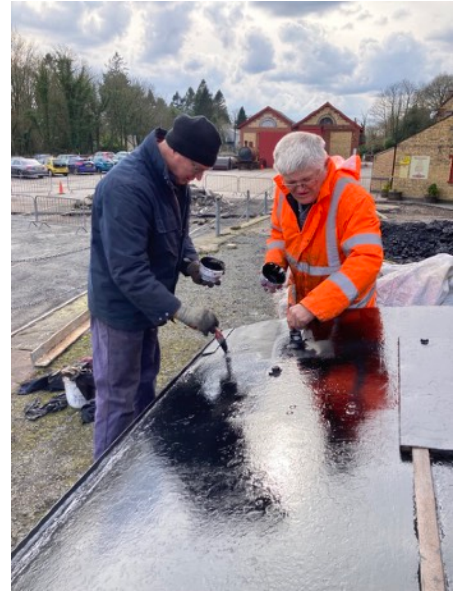
No further progress has been made on Repulse's boiler repair during March, however, we did take the opportunity (with the cab removed) to give the roof a paint refresh. Photo (right) shows Steve Maher and Mark Brown on the task. With the assistance of Graham Magee we also did the same for Victor.

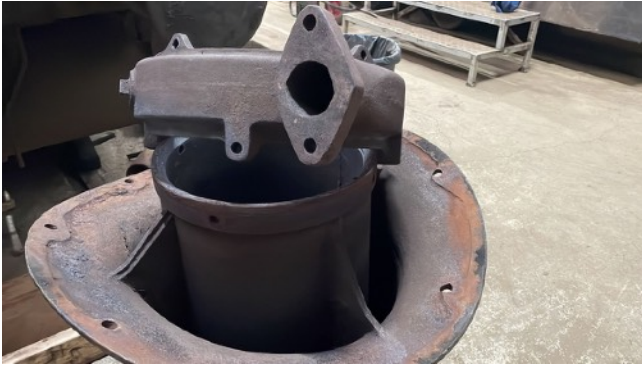
Four attempts at heating up the ejector exhaust ring to chimney joint were required before Chris Beet managed to split them. Photo (left) shows the items now separated.

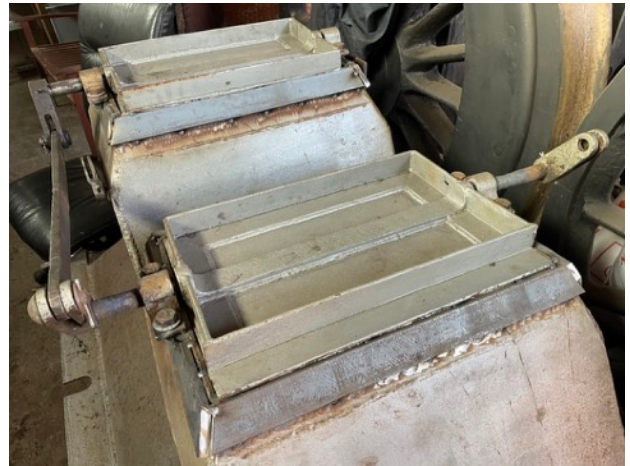
The ashpan hopper openings have had stiffening bars added to mitigate risk of heat distortion. Photo (right) shows the upturned ashpan with the bars tack welded into place ready for finish welding.

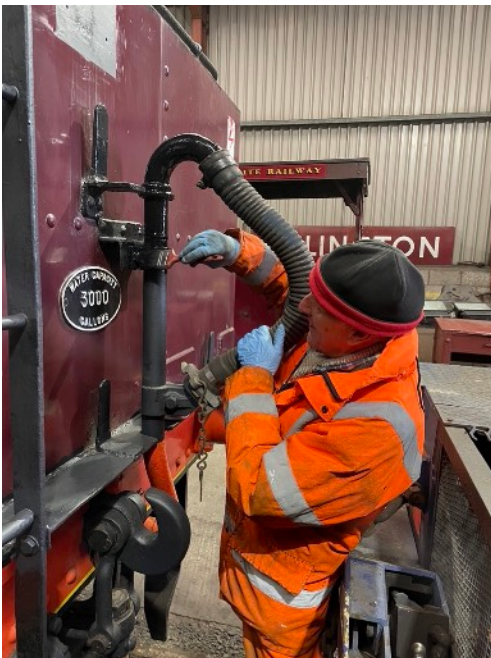
On another Saturday in March, the injectors received their overhaul. This included repacking of the water valves. One of the steam cones was identified as needing replacement and this will need to be sourced. Pictured (right) is the right hand injector receiving attention from Chris Beet

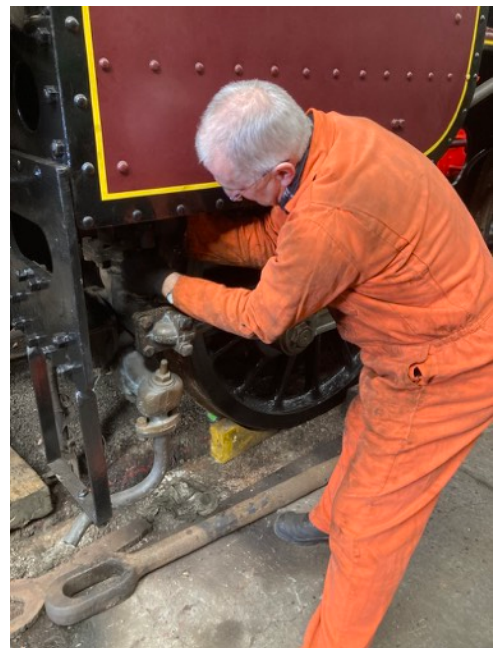
And finally...we still keep finding bits of painting to do: Photo (above) shows Graham Magee applying gloss to the vacuum pipe and the rear steps whilst accessories such as the ejector and the AWS warning box (photo right) have received some cosmetic care.

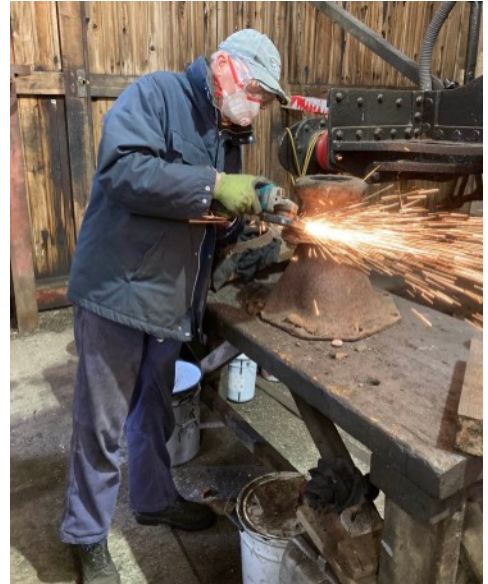
The task list on the Ivatt has temporarily tailed off as we await the boiler so we have been able to do a few volunteer tasks back on the Fairburn. The chamber between the frames beneath the smokebox has been surface cleaned and is now getting a coat of paint. The blast pipe and blast pipe cap are being separated as a first step towards getting replacement parts and the ejector ring has been cleaned up. Photo (right) shows Steve Maher working on the blast pipe.

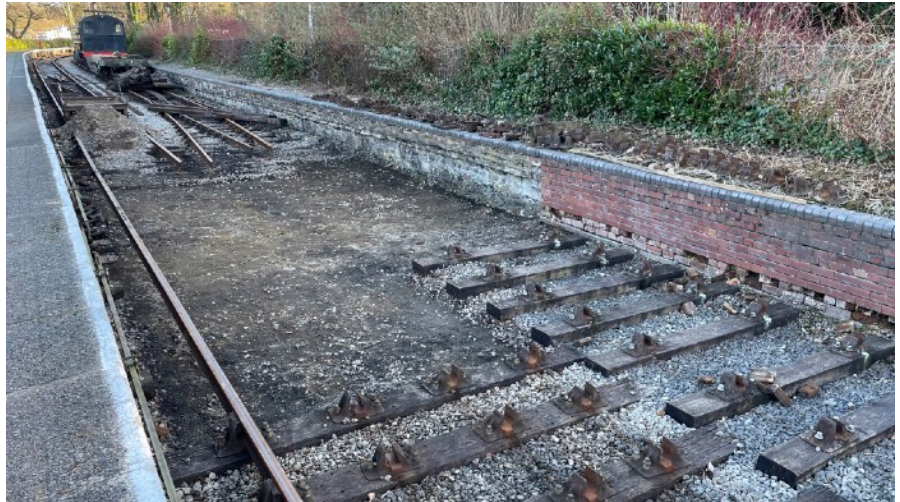
In March the operations staff and John Fowler engineering team replaced the long timbers under the run round loop crossover at Lakeside, nearest to the buffer stops. Photo (right) shows the old timbers, track and ballast removed on 7th March.

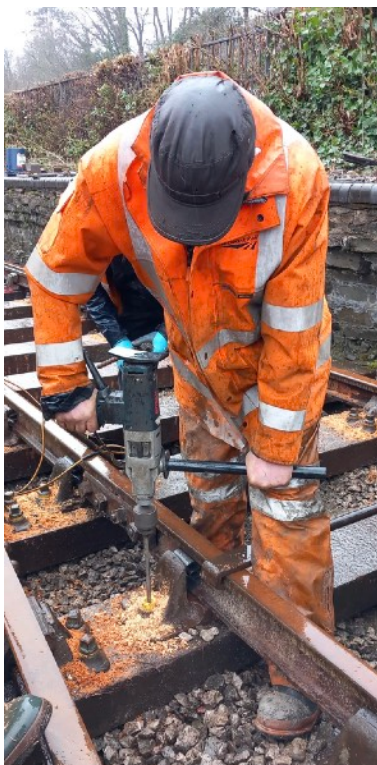
By the last week of March all the new timbers and track were in place with the final chairs attached. Photo (left) shows Alistair Colquhoun from John Fowler & Co. drilling the timbers. Photo (below) shows L&HR operations staff as they get close to task completion. Just the re-ballasting was required to finish the job off.
