Update on activity at the Lakeside and Haverthwaite Railway - July 2023

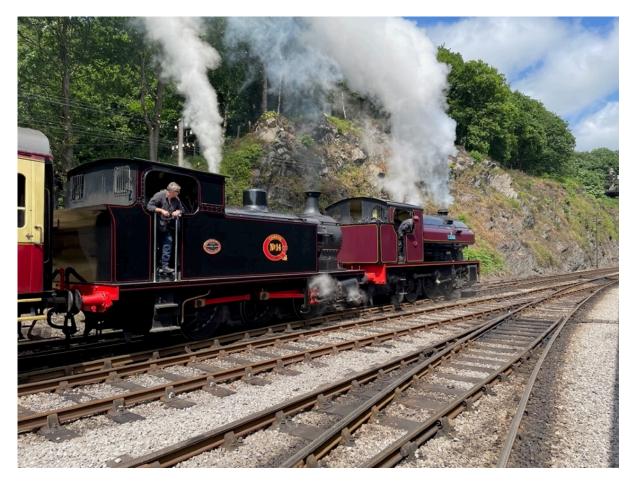
Bagnall 'Victor' has now returned to service (more details below) and is seen here (photo above) on its first test run on the 21st June.

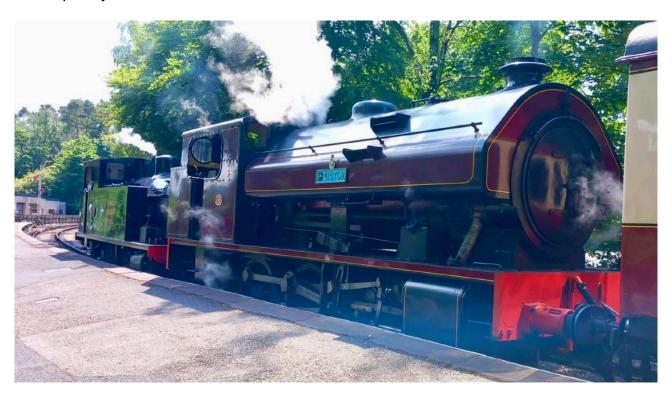
A successful test run to Lakeside and back took place, double heading on a service train with Barclay No.1245 (seen at Lakeside below). The main steam pipe covers were subsequently refitted and Victor re-entered service on the 22nd June.

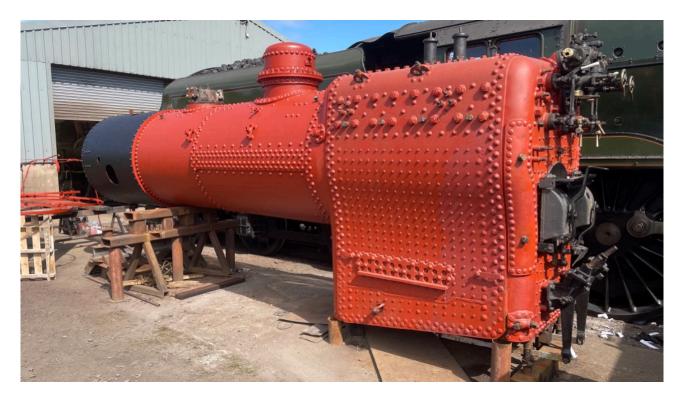
The task of surface preparation and priming of the boiler and smokebox was completed by a team of volunteers from Haverthwaite on June 1st. Photo (below) shows the completed task which also included cleaning and painting the crinolines (seen in the background).

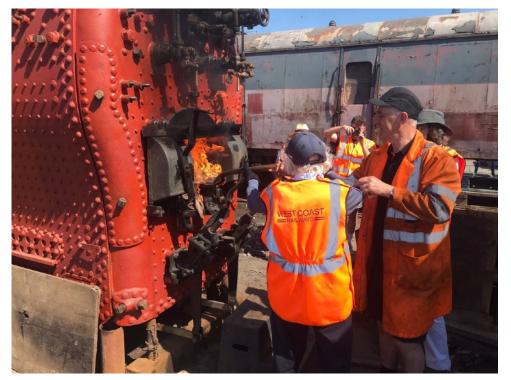
On the following day we achieved a significant milestone when the locomotive owner, Betty Beet, lit the first fire in the boiler since it was withdrawn from service on the East Lancashire Railway in 2002. Photo (below) shows Betty placing the shovel filled with burning rags into the firebox assisted by Chris Beet.

Through the next week the boiler was steamed several times at up to full pressure. There were only a few minor leaks that were readily rectified. The boiler insurance steam test was then scheduled and took place successfully on June 15th.

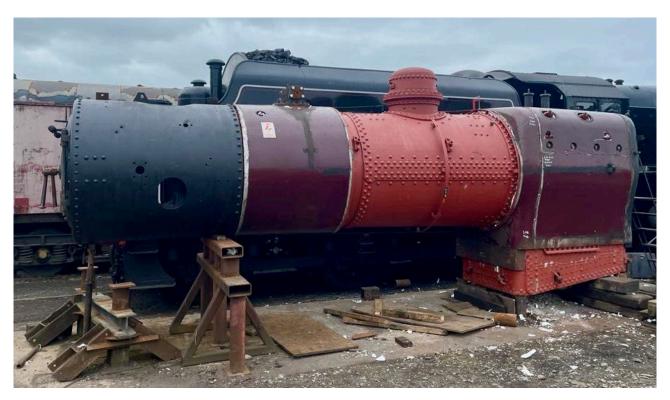
Chris Beet's team then repaired and refitted the crinolines and applied the boiler insulation wrap. They attached the cladding except for the rear barrel section as can be seen in the photo (below). The rear barrel section was left to facilitate crane slinging when the boiler is lifted and placed into its frames. The logistics of lifting and transporting the boiler to Haverthwaite are now being arranged. It is proposed that the completed boiler for 42085 will also be brought to Haverthwaite on the same day to reduce overall crane hire costs.

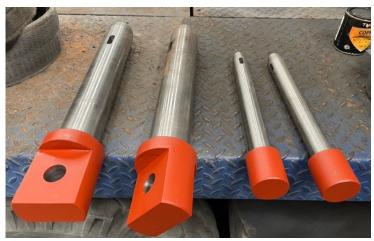
These continue to be 'ticked off the list' and it is basically ready to receive the boiler. The new intermediate draw bar pins and failsafe link pins are ready and can be seen (part painted) in the photo (above left). The boiler bands and rear barrel cladding have also been readied for assembly. Photo (above right) shows volunteers Roger Birkett and Mark Brown priming the boiler bands.

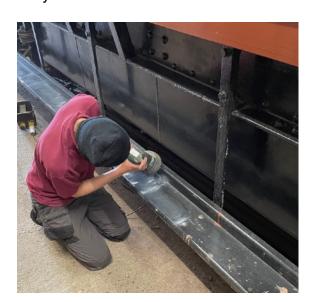
The end is in sight for the restoration of the LMS 20 Ton brake van. The main side panel and verandah decking wood replacement was largely completed pre-covid by David Birkby. The finishing off and painting has been worked on since, led by Paul Timewell and supported by several other volunteers. Pictured (right) is Billy Pearson preparing the running boards for painting.
