Update on activity at the Lakeside and Haverthwaite Railway - August 2023

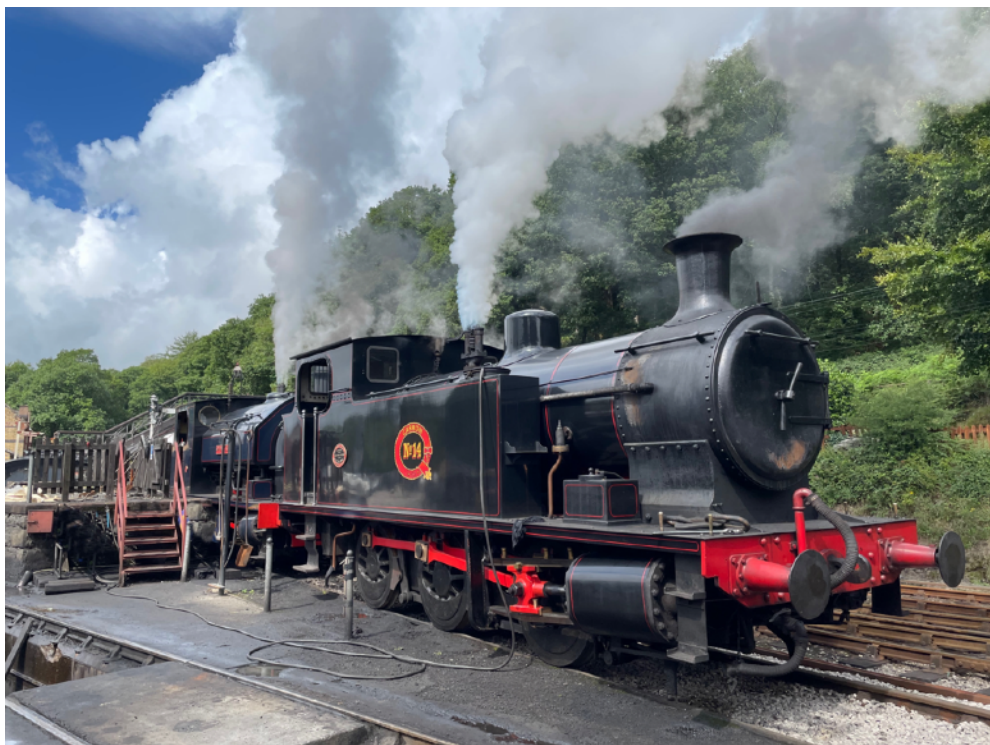
Unusually, we saw our four serviceable steam locomotives all in steam together on July 12th. Barclays 'David' and No. 1245 plus Bagnall 'Princess' were undergoing their annual steam test. The photo (below) shows both No. 1245 and 'Princess' at full boiler pressure during the tests.

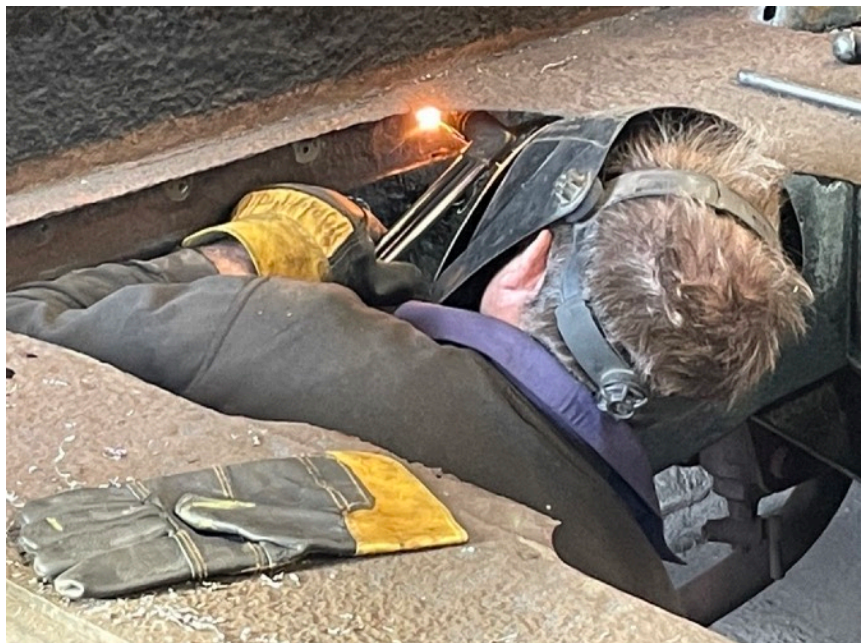
Alastair Colquhoun from John Fowler Engineering has successfully removed the rear horizontal stretcher from the frames (photo right). This has involved removing a significant number of rivets. This stretcher is located beneath the footplate and has suffered from the 72 years that it spent in a corrosive environment. It will be replaced with a new fabrication.

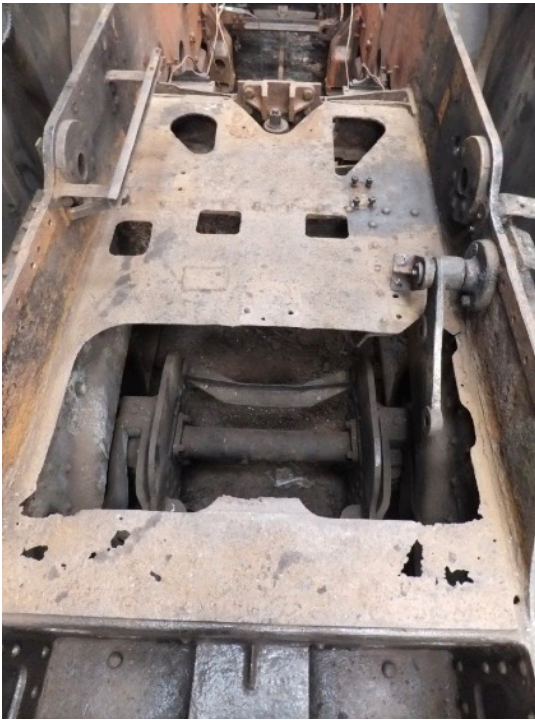
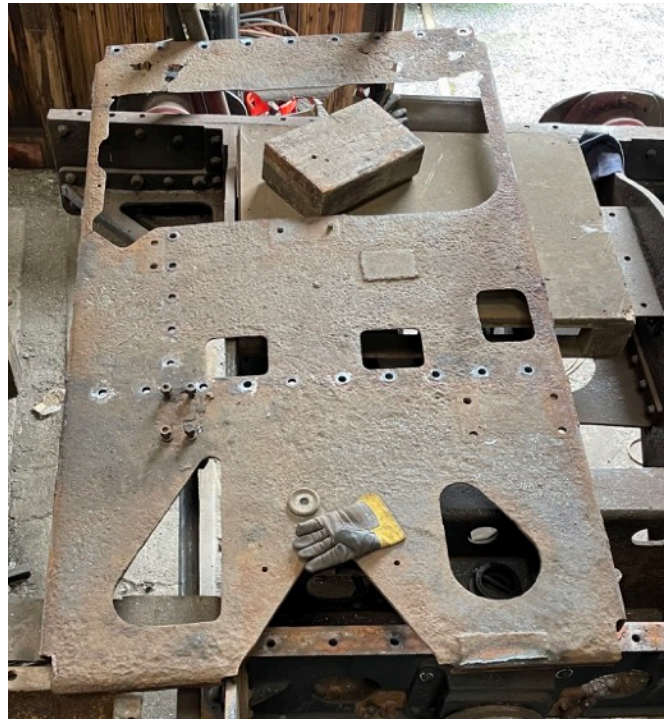
The photo (below left, taken in 2019) shows the stretcher in situ. Photo (below right) shows the removed stretcher on 26th July.

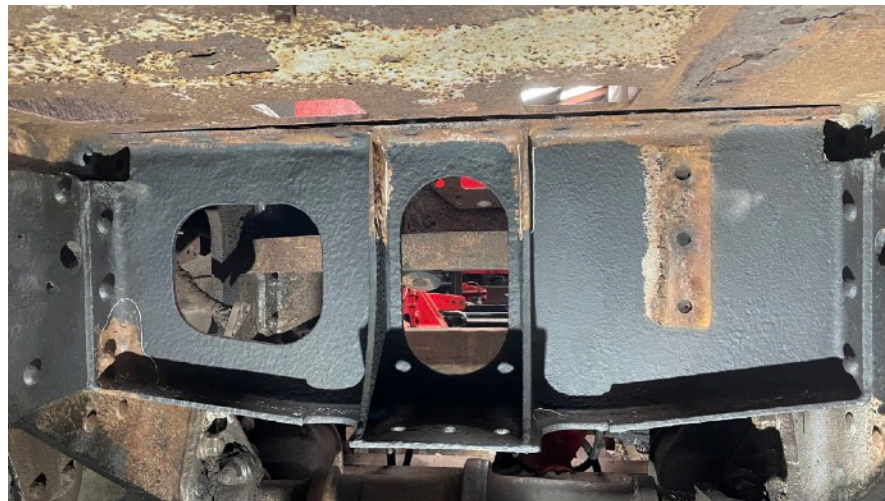
Removal of the horizontal rear stretcher first required dismantling the water scoop pivot bracket, which was in turn mounted to the water scoop vertical stretcher (pictured below). The top of the picture shows the underside of the horizontal rear stretcher. The rivet holes (top right) indicate where the pivot bracket had been mounted. The water scoop had been removed sometime during BR service.

Removal of the horizontal stretcher has given us access to the steam brake stretcher fabrication which also needs repair by the John Fowler engineering team. This whole area between the frames can now be cleaned back to bare metal, primed and painted. Some further disassembly of components outside the frames is required to give access for the riveting gun (for when the new replacement horizontal stretcher is fitted).

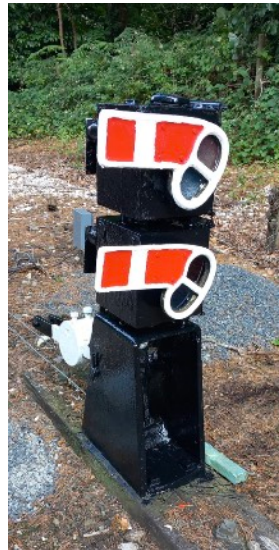
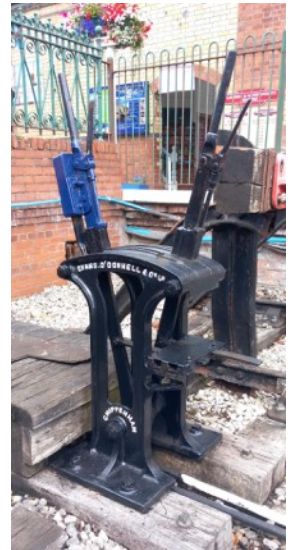
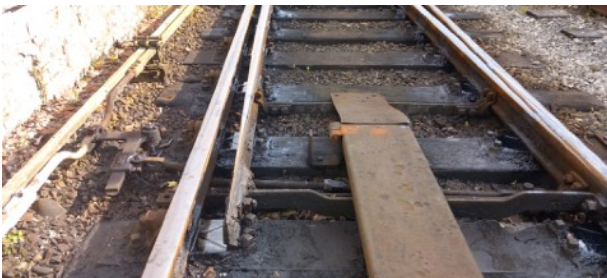
Over the summer months volunteer Cliff Kilshaw has been busy at Lakeside on several maintenance and improvement projects. He has freshened up the paintwork on the repeater signals for the Lakeside run round loop and has similarly painted the Lakeside ground frame (photos right). Keith Brewer, Fred Jones and Cliff have progressed the reconnection of the telegraph link to Haverthwaite. This was affected by the creation of the new West Windermere Way path as it approaches Lakeside.

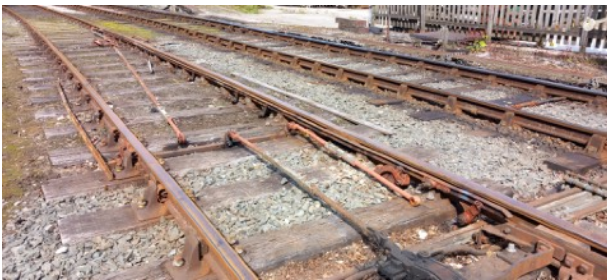
Cliff has also done adjustments to improve the crank action on the Lakeside ground frame points as seen on the left of the photo (left). This has given them a smoother operation.

His other Lakeside project is to re-establish signal box operation of the points to what was previously known as the 'long siding'. Prior to BR closure this siding stretched as far as the current location of the new footbridge and could accommodate carriage stock from multiple excursion trains. The point linkage is in place as is the facing point locking bar (photo left). The task of making the final connections to the box remains.
