## Update on activity at the Lakeside and Haverthwaite Railway - February 2021

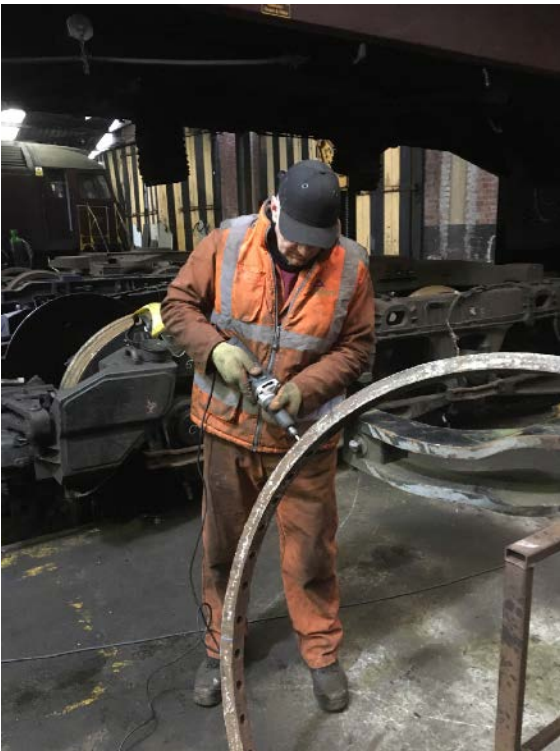
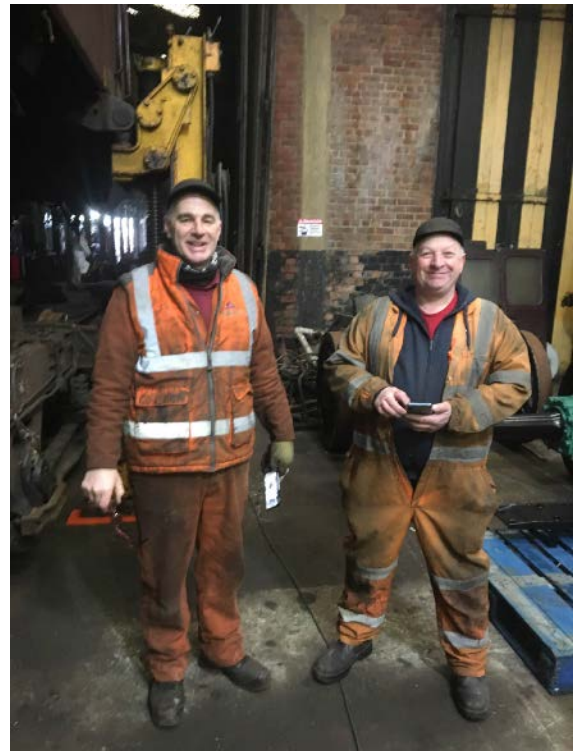
On the **Ivatt 2MT 46441** in early January John McKay and Chris Beet (photos below) have drilled out pilot holes for all of the various smokebox fittings that were previously marked out. The holes in the front boiler ring that the smokebox is riveted to (pictured below) have been cleaned out. The ring is next to be tacked in position for final sizing of the wrapper.

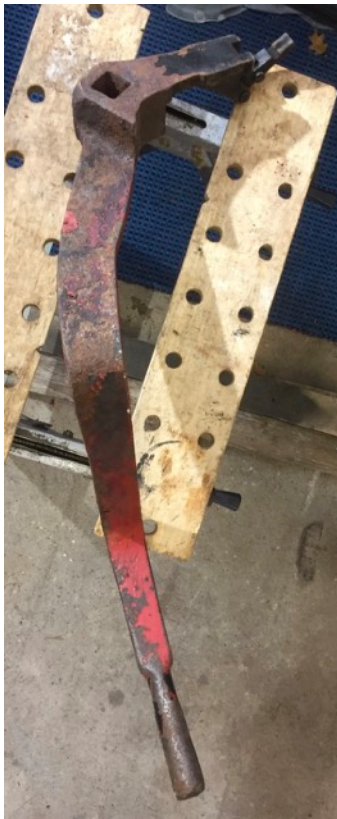
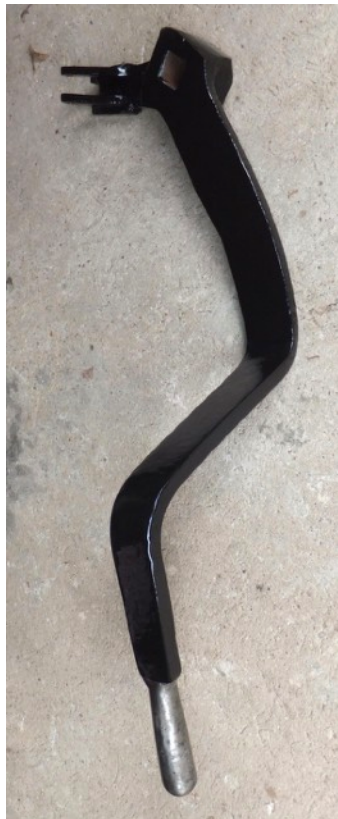
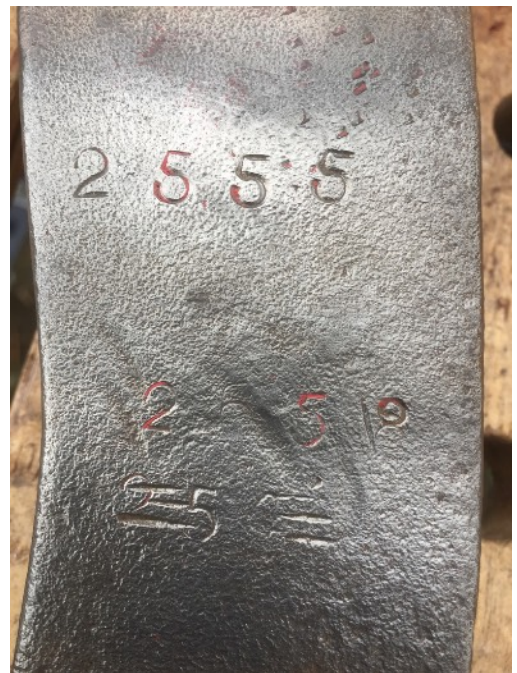
It is always interesting to see what is revealed when removing old paint from locomotive components and as the pictures below show, 42085's regulator handle was no exception this month. Cleaning the surface to bare metal revealed evidence that it had been previously fitted to three LMS Stanier 2-6-4 tank locomotives numbered 2546 (I think), 2658 and 2555

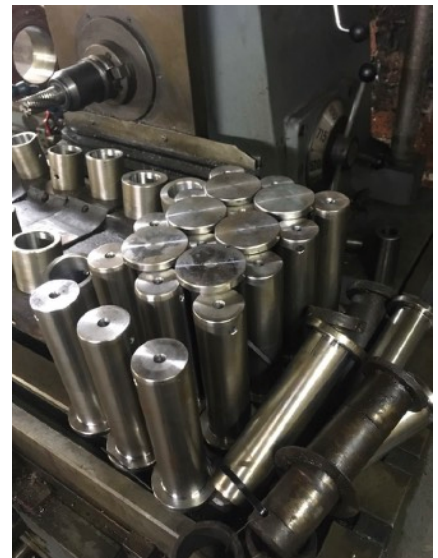
**Hunslet Austerity 'Repulse'** remains in the bottom shed workshop for winter maintenance with it's motion dismantled. Rectification overhaul of general wear and tear led by the John Fowler & Co team continues. New pins and bushes have been manufactured for use on the brake hangers. Picture (right) shows the new pins, bushes and a used worn pin as comparison.

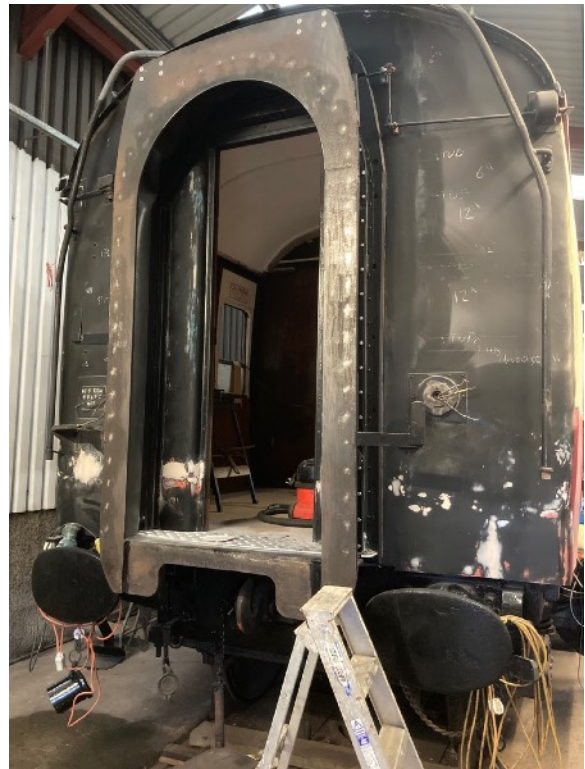
M4255 (pictured right) is nearing the end of a major refurbishment. This has included body structural replacement of coach end crash pillars and drag box stiffening plate. The gangway buffers have been repaired including the gangway connection tensioners. The toilet compartment has been removed and the enlarged entrance vestibule visible in the photograph has been refloored and has new interior wall paneling. The vacuum brake system has been overhauled and the coach is having a full repaint utilising Alan's professional painting skills.

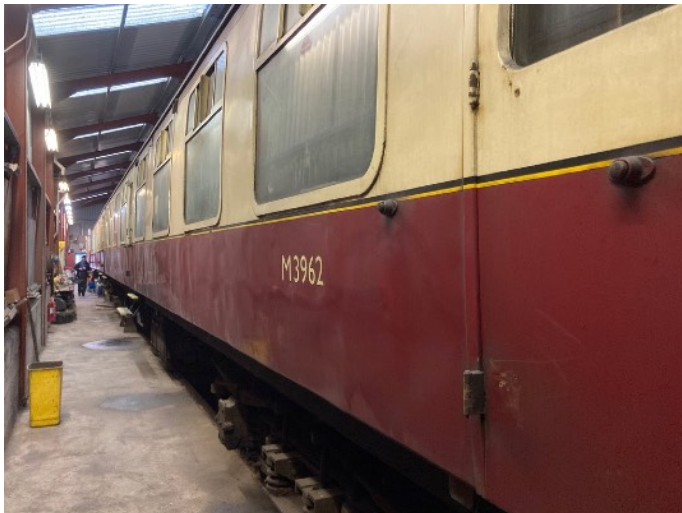
M3962 (pictured left) is having a more cosmetic overhaul covering minor maintenance and a full repaint to allow it to return to service quickly for the start of the 2021 main season.

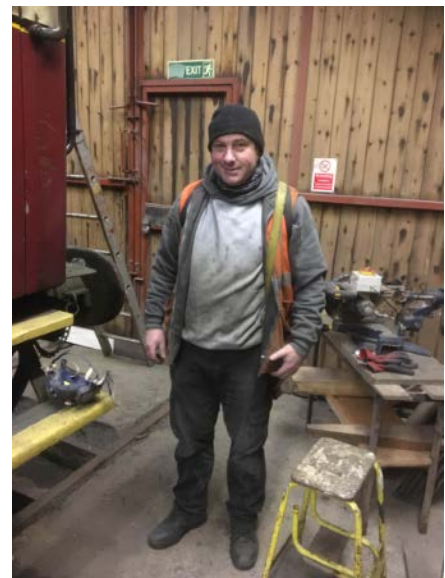
Photo (right) shows Alan Hardaker preparing to work on roof painting of M3962.

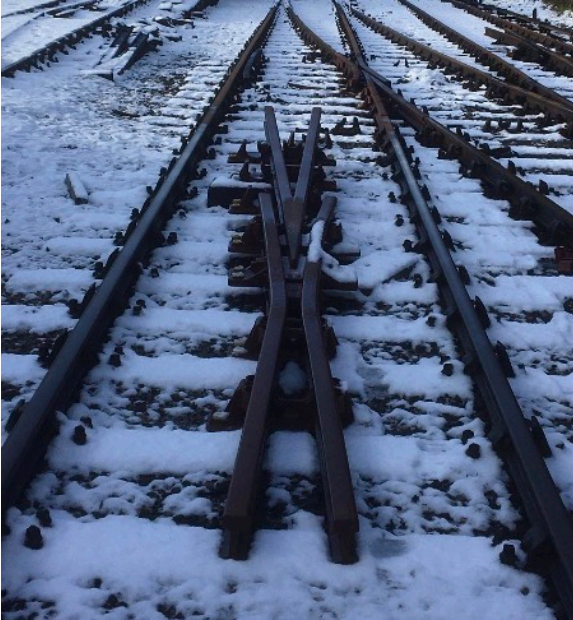
With the track to Lakeside closed to rail traffic, Haverthwaite No. 10 crossover is being replaced using two new nose and wing rail sections plus replacement running rails. Martin Gregory and the John Fowler & Co. Engineering team are completing this work. This is one of the key 'close season' maintenance tasks that must be completed before we can run trains again.

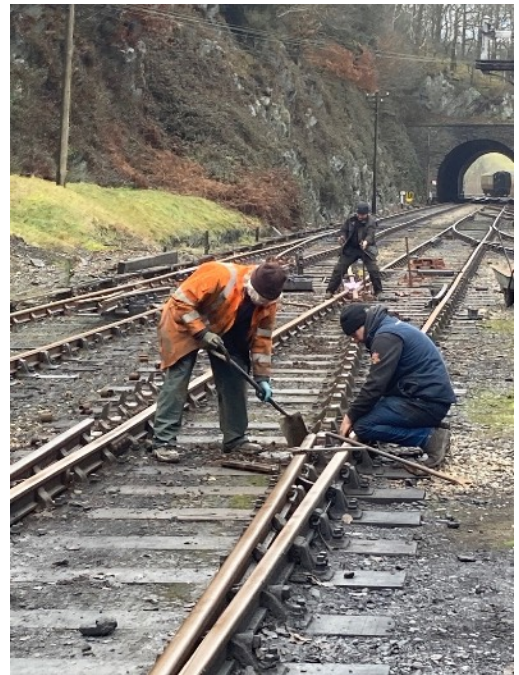
Photo (left) shows close up of one of the new nose and wing rail sections.

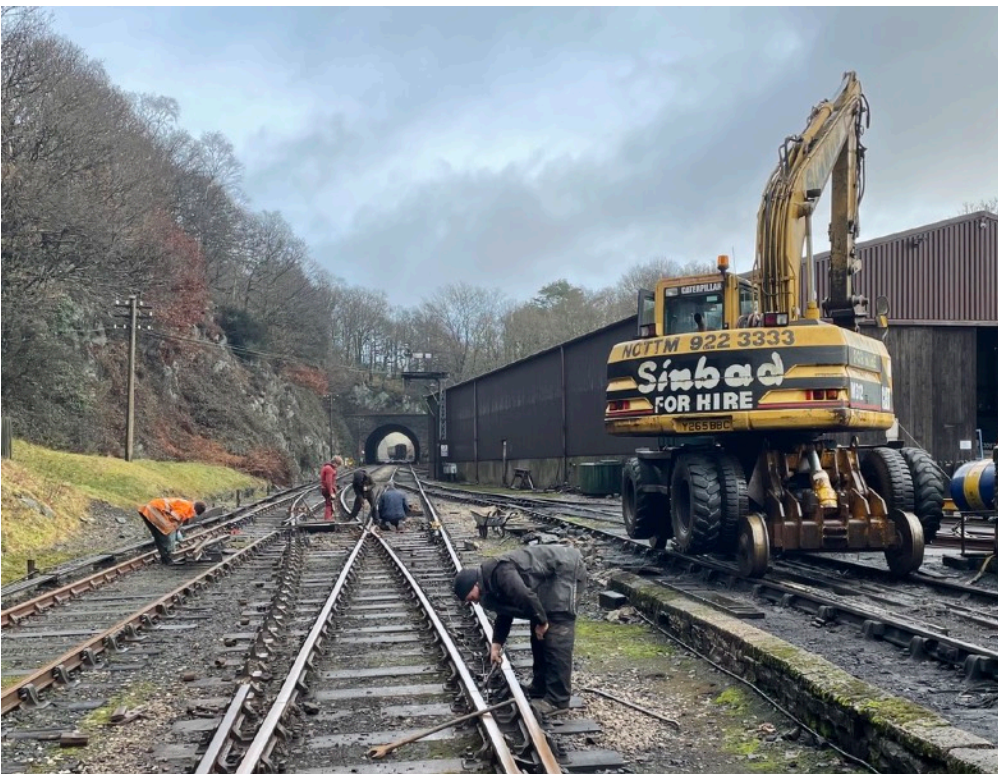
Photos (right and below) show the progress made by Martin, Alex Sharphouse and his John Fowler & Co. engineering team. New crossover sections are being fitted and old running rails removed.
