## Update on activity at the Lakeside and Haverthwaite Railway - November 2021

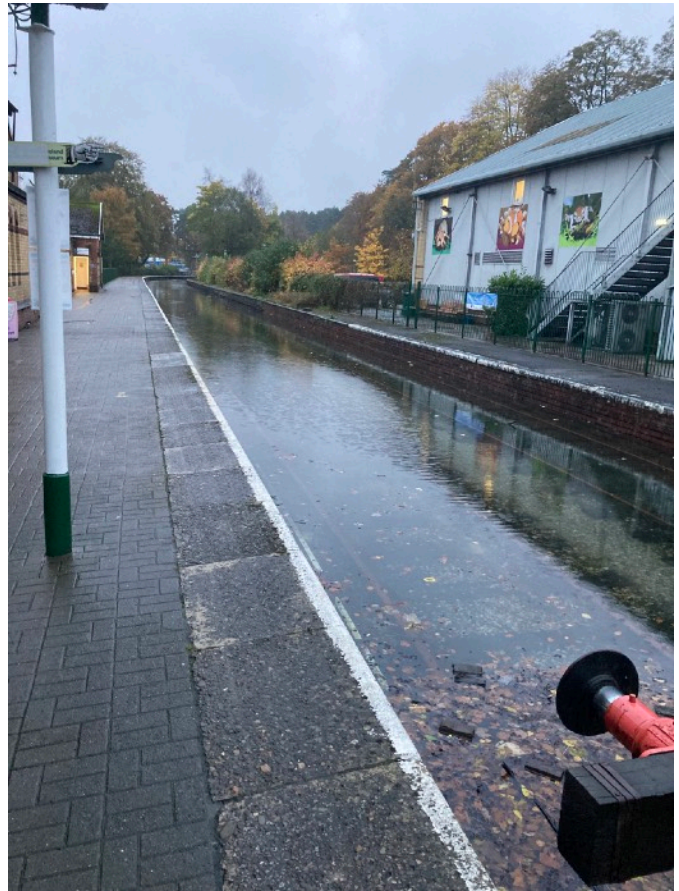
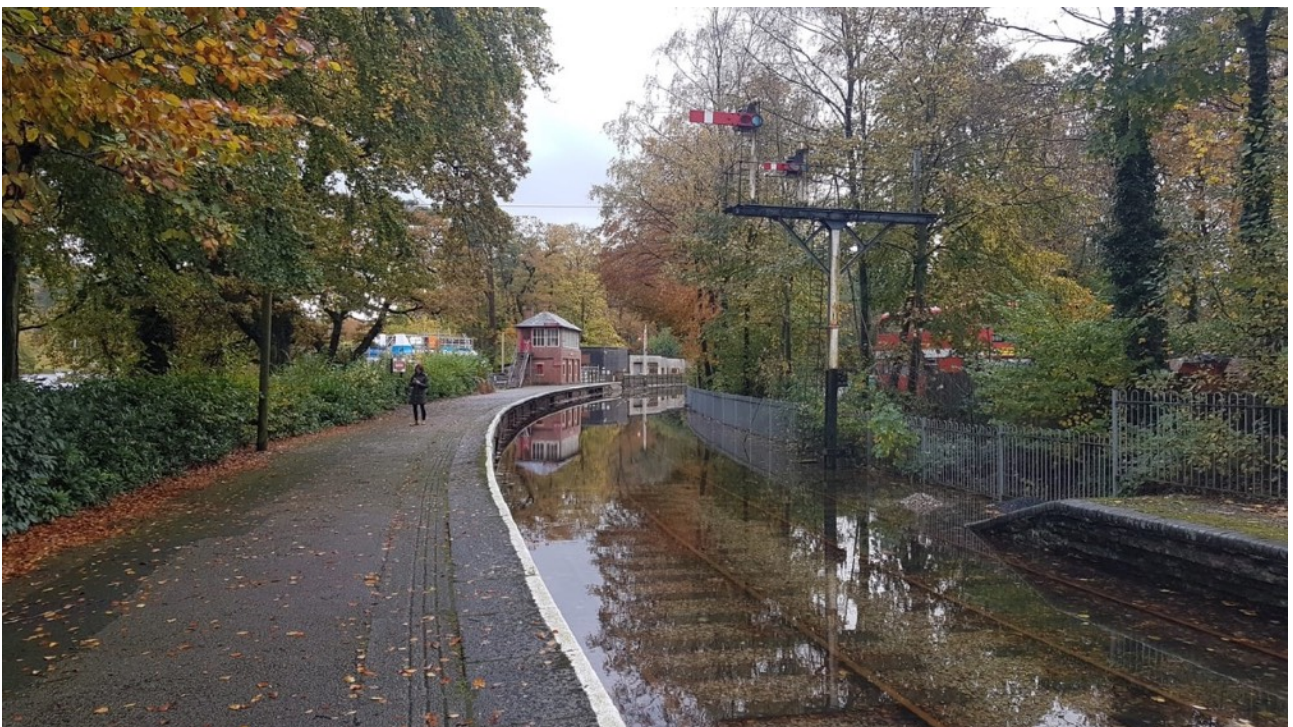
Business was reasonable for most of October. The school half term holiday started well with visitor numbers holding up despite some significant Lake District rainfall. Unfortunately by Thursday 28th October the lake level had risen by 1.5 meters and the track at Lakeside Station was underwater. Services were suspended, only restarting on the last day of the season (31st October). Photo (right and below) show Lakeside Station - looking more like a canal - on 29th October.

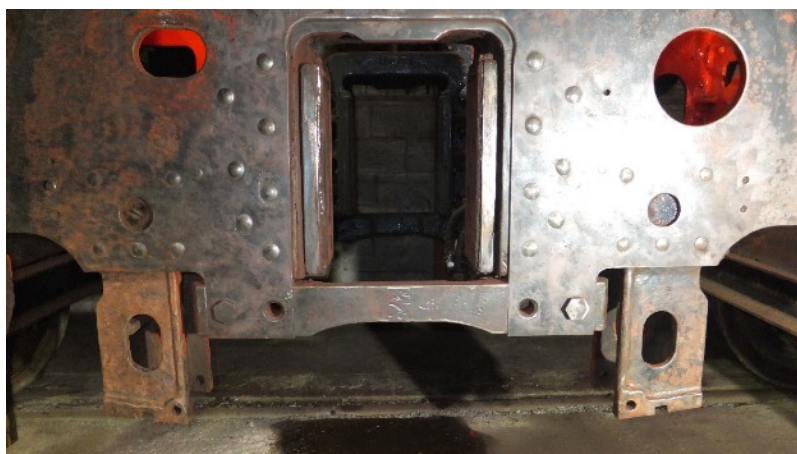
There is still plenty work to do on preparing the mainframes for painting. Steady progress continues as evidenced in the photo (right).

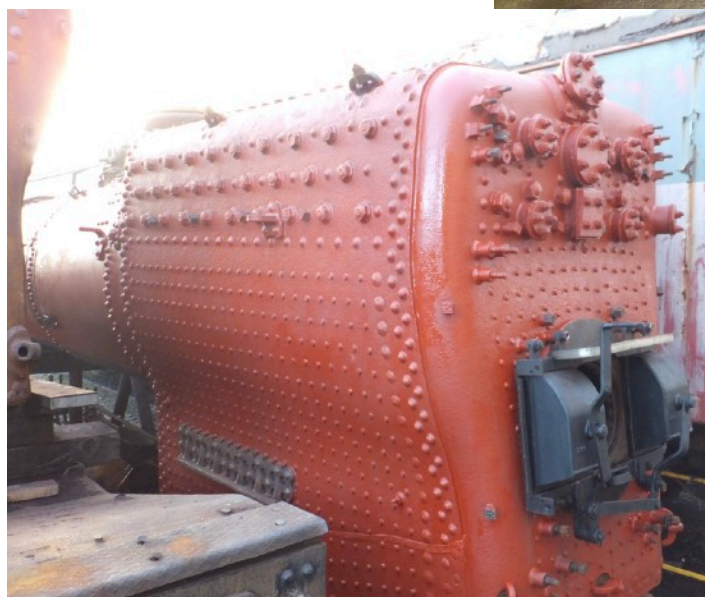
On the boiler, Tony Mayo, Fred Jones and Steve Maher have had two days making great progress on surface preparation and painting at Carnforth (see photo left). It probably needs another 3 days or so to complete the task but outdoor painting is a challenge in the winter months.

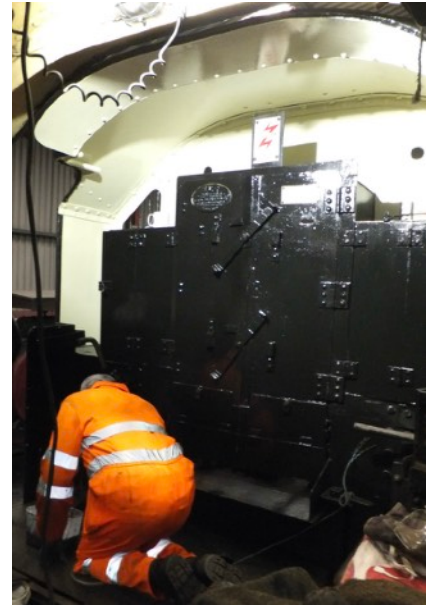
The tender mechanical overhaul including repaired drag box, water space fabrication repairs and new tender cab roof has been complete for some time. The internal tender cab painting is also now complete. See photo (right). Cab internal painting has moved on to the loco itself. A review of the remaining overhaul plan has taken place and the good news is that (subject to careful cost monitoring) it can now be funded. Our intention is that it will be pursued in full and with priority. The status and main elements of the plan are as follows:

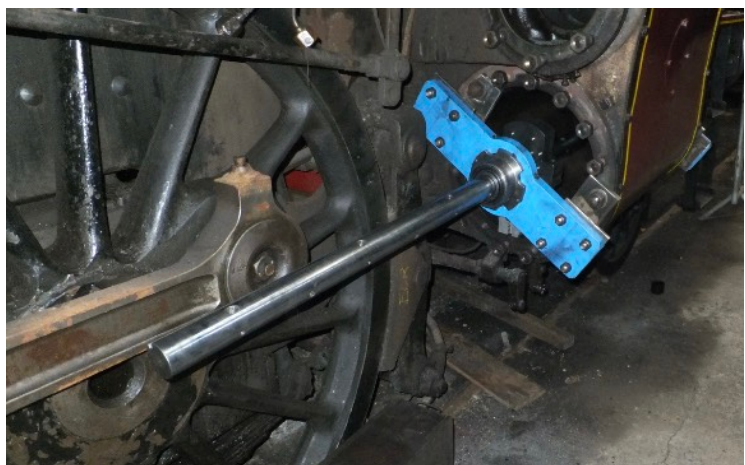
- Material has been ordered for a new intermediate drawbar to be machined.
- Valve and cylinder bores are now machined. Photo (right) shows the tooling set up for machining the right hand cylinder bore.
- New valve heads and spindles have been delivered. They now require machining to size.
- Material for piston and valve rings has been ordered and will need to be split and machined to size.
- Once the piston rods have been removed from the old heads they will be checked and reground if necessary before fitting to the new heads.
- Cylinder drain cocks will be removed for inspection and refurbish.
- John Fowler Engineering will carry out an axlebox pad exam and assess that lubrication is in good order for all moving parts.
