Update on activity at the Lakeside and Haverthwaite Railway - March 2022

Ivatt 2MT 46441

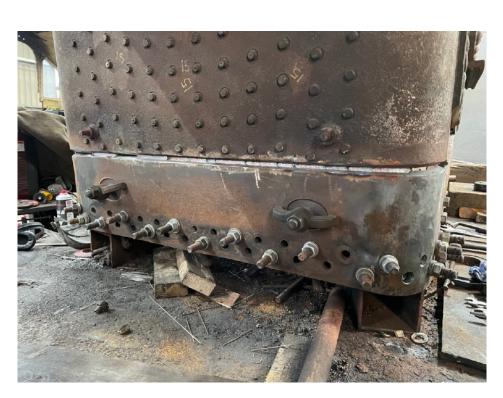
Photo (left) shows the lower throat plate now drilled for the foundation ring rivets and with mud hole doors in place. The welding is underway.

Good progress continues with the boiler overhaul.

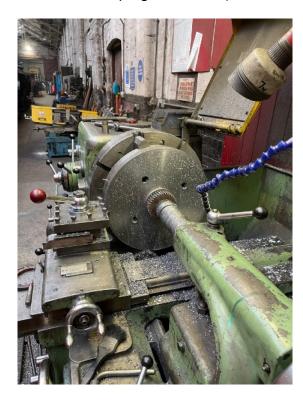
The first of the replacement piston head castings has now completed machining and just needs the core plugs inserted (Photo below left of machining in progress).

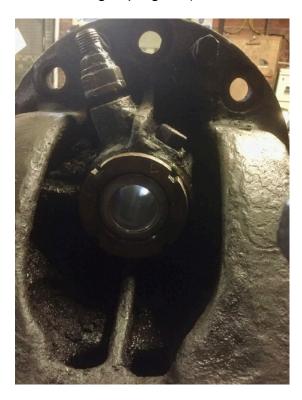
The four valve spindles bushes have been machined to size and fitted within the valve end covers (For example see photo above right). The process of gapping the valve rings can now take place.

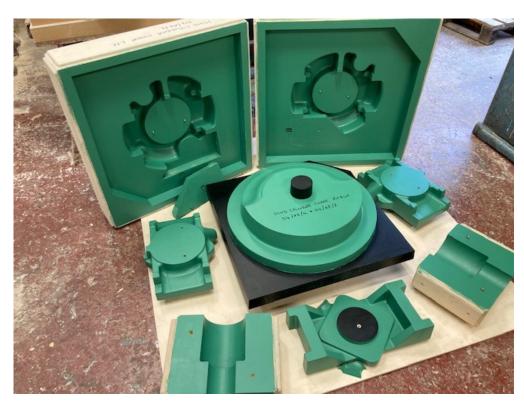
The new cylinder end cover pattern equipment (pictured below) is complete and ready to pass directly to the foundry for casting.

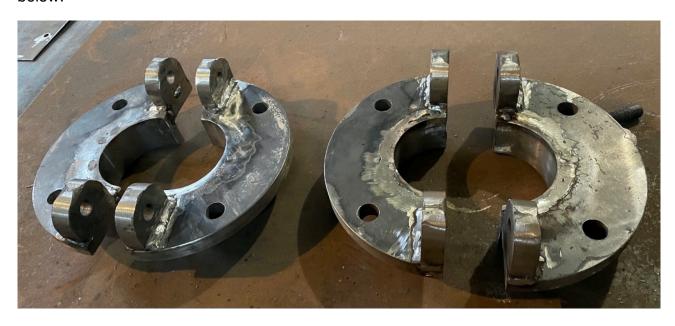
New gland plates for the main steam pipes have now been fabricated and are pictured below:

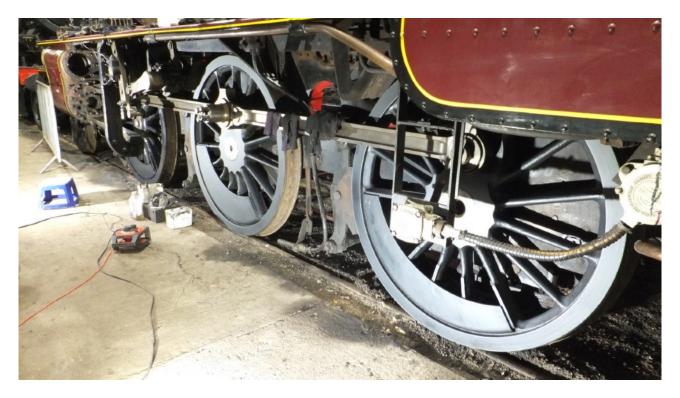
The main driving wheels are being smartened up with a quick paint before all the motion is reassembled. Photo (below) shows the undercoat applied to the left hand side

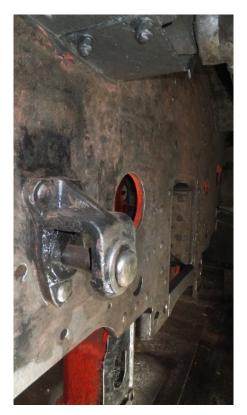
Photo (left) shows the frames prior to priming.

The marathon task of removing the encrusted oil dirt and old paint from the exterior frame surfaces is starting to look good. We are very grateful to several volunteers who have helped here since the frame lift but a special mention must be made to Fred Jones who has spent countless days on this task. The top coat of paint is now being applied and it makes a striking improvement to the appearance of the loco chassis.

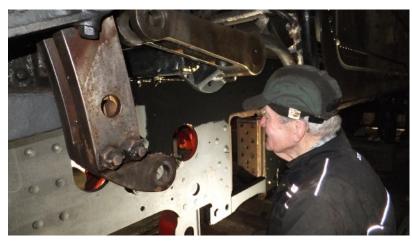
Photo (above) shows Fred Jones starting to apply a top coat of paint.

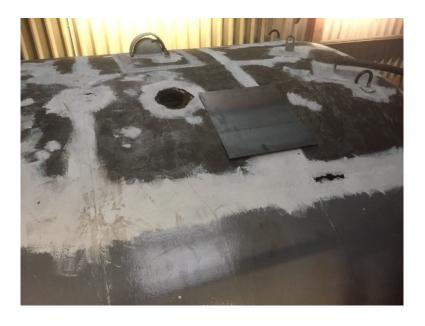
BR Mk1 TSO M3962 overhaul continues and the end is in sight. The side skins have been replaced and repaired where necessary and more recently the roof has seen attention from Martin Gregory, especially in the vicinity of the end roof guttering. Several holes in this region have now been patch repaired. Door woodwork is getting attention with new pieces being shaped and fitted by David Birkby. Photo (right) shows the roof above the water tank prior to repair with tank filler pipes and guttering removed.
