Update on activity at the Lakeside and Haverthwaite Railway - May 2023

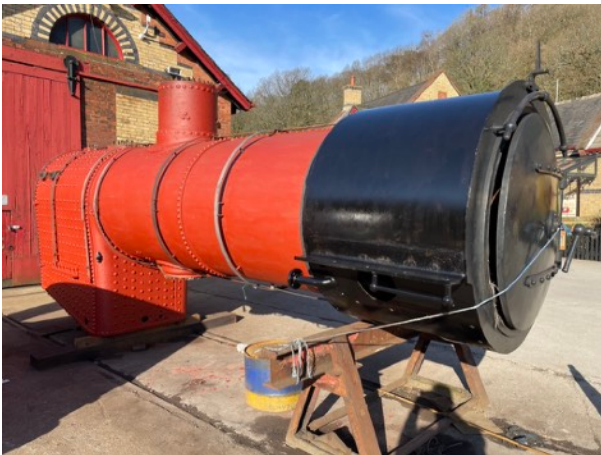
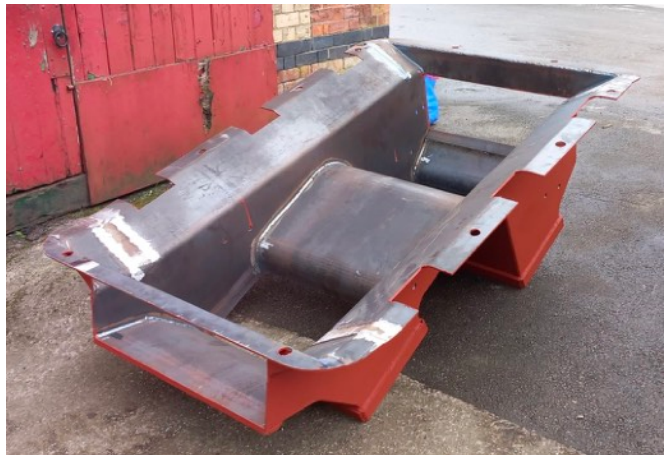
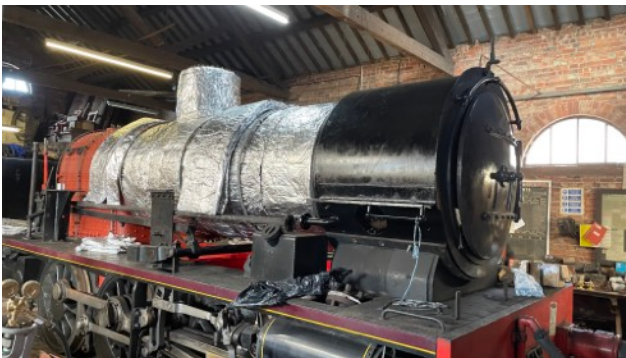
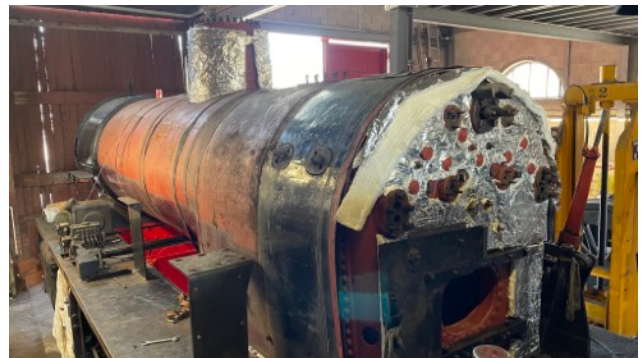
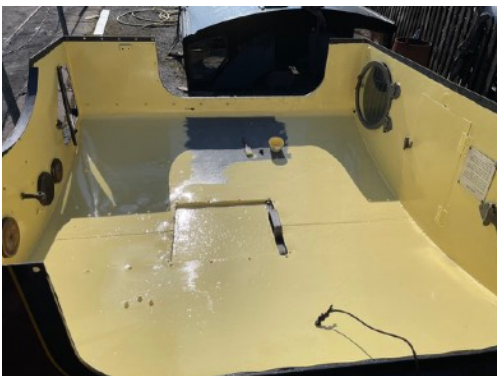
Reassembly of Victor by the John Fowler and Co. team is proceeding at a good pace. As can be seen in the photographs below. The newly fabricated ashpan has been fitted to the boiler and the boiler is now back in the frames. The ashpan hopper and damper mechanism have been attached. In mid April the boiler insulation and cladding were being fitted.

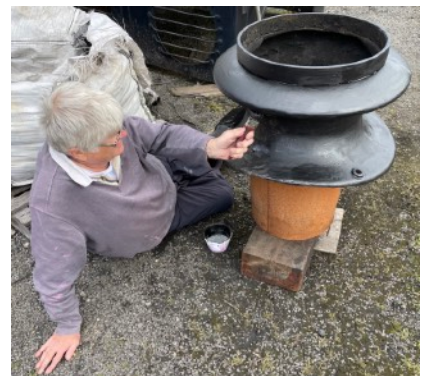
Whilst Victor's cab roof is disassembled from the loco we have given it a brighter coat of paint inside - and Mark Brown has done the chimney too. (Photos left and right).

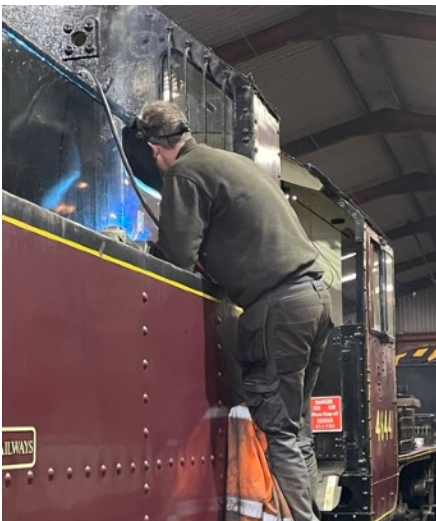
Further hydraulic testing has taken place on the Ivatt boiler. The firebox area, where the vast majority of the repair work has taken place, is fully watertight as is the rest of the boiler. The formal insurance hydraulic test will take place as soon as this can be organised. Attaching the smokebox to the boiler will be the next notable task.

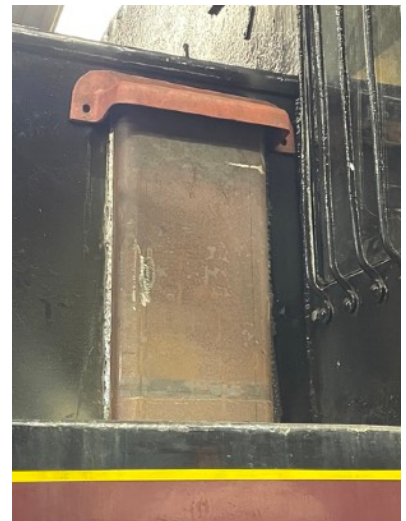
On the tender Alistair Colquhoun from John Fowler and Co. has fitted the newly fabricated water tank forward vents. Photos of the part finished task are shown here (left and right). These are now getting the required coats of paint.

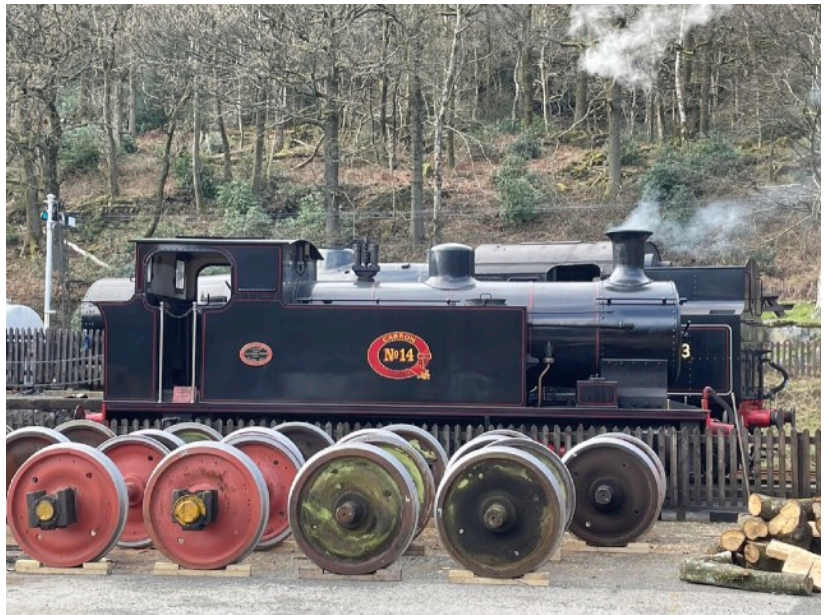
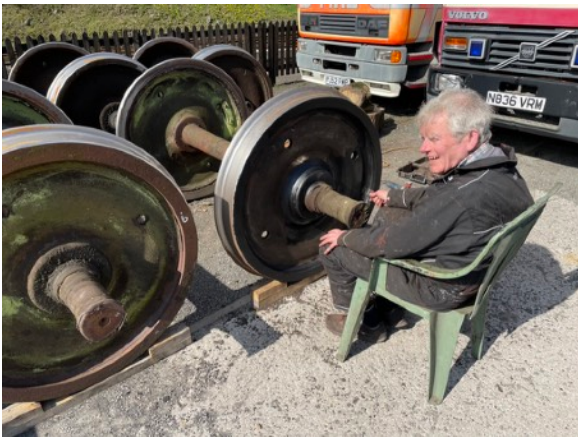
The spare Mk1 carriage wheel-set tyres have now been re-profiled and returned to Haverthwaite as can be seen in foreground of the photo (right). Fred Jones has started the process of cleaning them down and giving them a coat of paint (Photo below). Once painted they will be available for swap out as required.

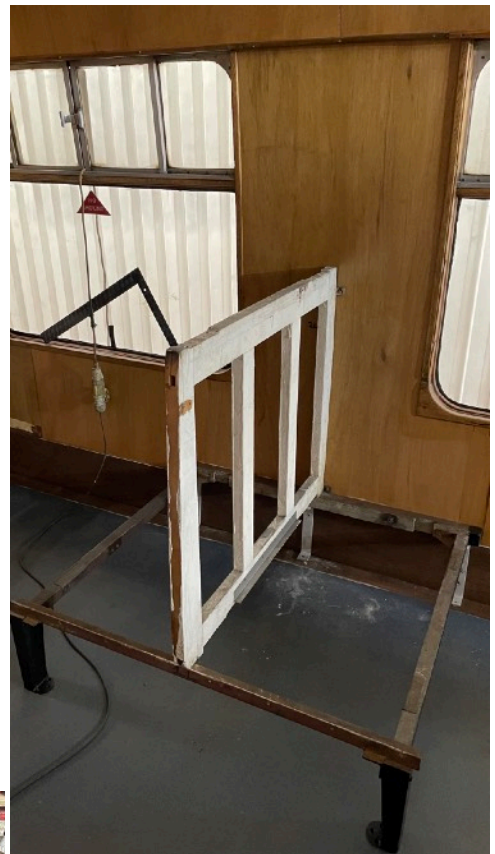
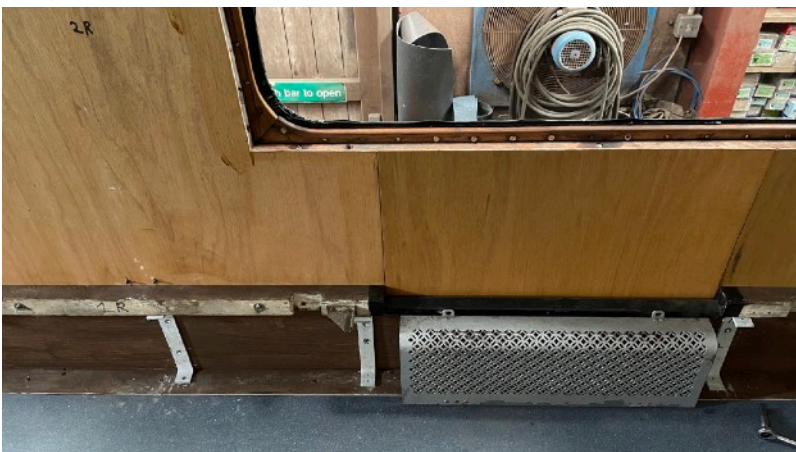
Mk 1 TSO M4410 interior has made steady but notable progress through the efforts of Martin Gregory with Wednesday support from David Birkby. As previously, Martin is still working on the first half of the interior. The floor covering is now fitted along with all the new wall paneling.

The lower woodwork is in place and this allows the steam heating pipes to be re-fitted. The first seat frames are also being installed. Photos (above and left).

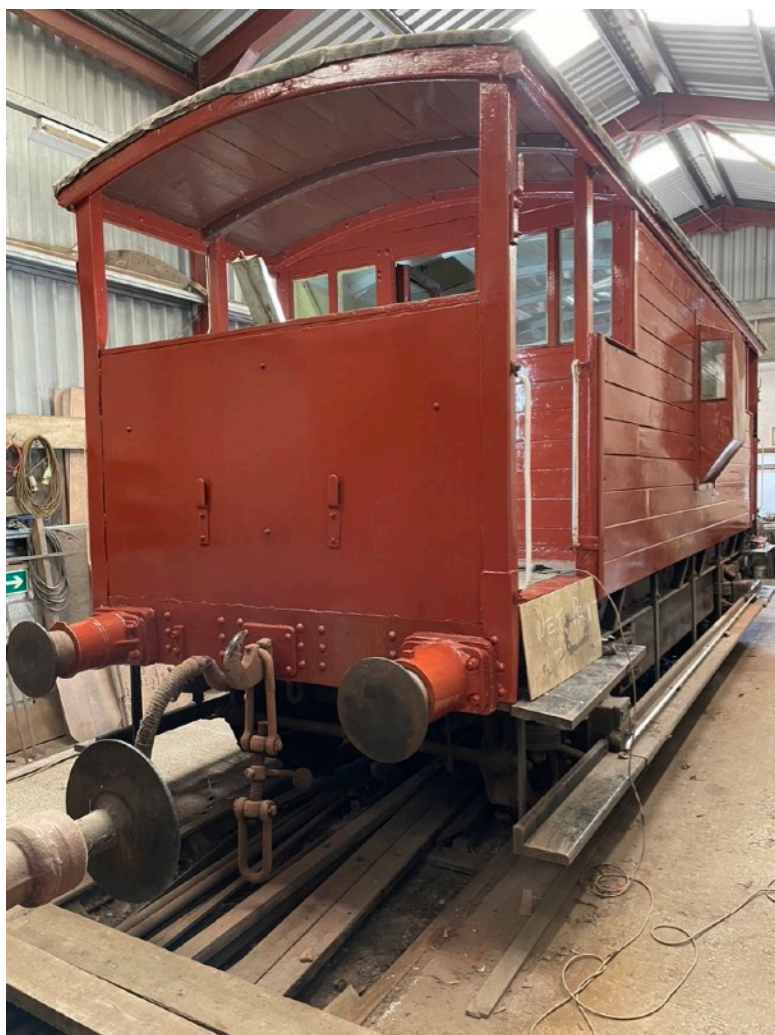
Meanwhile the Wednesday volunteer team have been doing restoration work on the LMS 20 ton brake van in phases for some time now. All the old rotten woodwork has been replaced and it is now getting a few coats of paint. David Birkby has led the woodwork activity and Paul Timewell has led the finishing and painting. The current status can be seen in the photo (left).
